EQUIPMENT VIBRATION REPORT

SAMPLE CLIENT REPORT

LOCATION: XXX

January 17, 2014

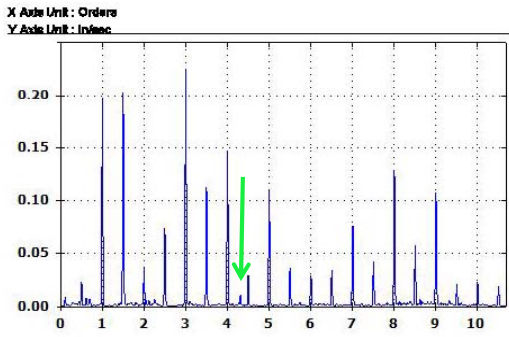
Fluke Location 1 Tangent

THIS UNIT IS EXHIBITING NON SYNCHRONOUS VIBRATION ON LOCATION 1 TANGENT THAT MAY BE BEARING RELATED AND WARRANTS MONITORING. A MORE DEFINITIVE DIAGNOSIS CAN BE MADE IF BEARING NUMBERS ARE PROVIDED. OVERALL AMPLITUDES ARE RELATIVELY MINOR AT THIS TIME AND IF THIS IS A BEARING ISSUE, IT CAN MOST LIKELY BE MONITORED ON A MONTHLY BASIS FOR MORE ADVANCED STAGES OF FAILURE. LOCATION 3 TANGENT HAS SOME RAISED FLOOR VIBRATION THAT MAY BE DUE TO POTENTIAL RECIRCULATION.

Data under load illustrates some non-synchronous vibration is present. Overall amplitudes are minor at this time and if a defective condition is indeed present, there is most likely time to monitor for more advanced stages. This may be bearing related.

MONITOR MONTHLY FOR REPEATABILITY AND INCREASES IN NON SYNCHRONOUS VIBRATION. ENSURE FLOW IS NOT RESTRICTED. IF PUMP PERFORMANCE IS POOR, RECIRCULATION MAY BE PRESENT AND SHOULD BE ADDRESSED.

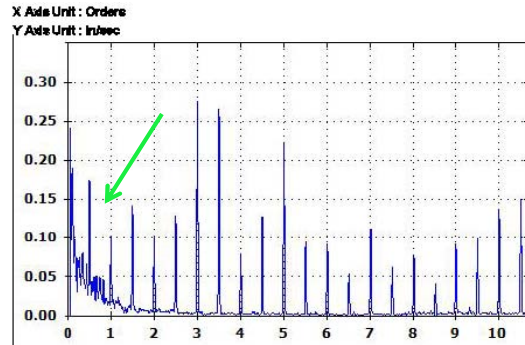
Fluke Location 3 Tangent

The fft graph below illustrates some raised floor vibration that is not a typical signature of this unit. This could be due to an ambient source of vibration or potential recirculation of flow.

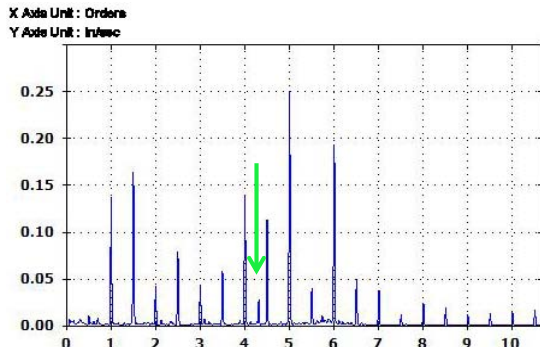
Fluke Location 1 Tangent

Non-synchronous vibration remains present even when unit is under no load. Without more equipment information a determination cannot be made as to if this unit has a defective condition. This may be bearing related.

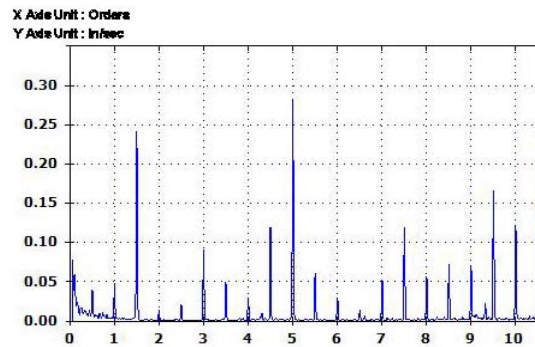
Fluke Location 3 Tangent

Raised floor vibration remains present when tested under no load but in lower amplitudes.

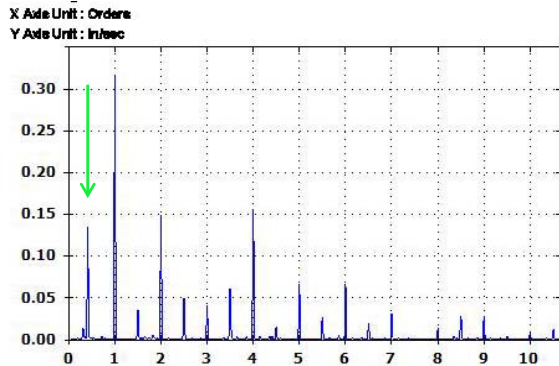
Fluke Location 1 Tangent

THIS UNIT HAS SOME SLIGHTLY ELEVATED LOW FREQUENCY VIBRATION THAT MAY BE COMING FROM A NEARBY UNIT, BUT COULD BE DUE TO BELT ISSUES. THIS VIBRATION WAS PRESENT WHEN THE UNIT WAS TESTED UNDER LOAD AND UNLOADED CONDITIONS.

The peak marked by the green arrow below is coming in around .4x, and is likely due to an ambient source of vibration such as a fan belt, water pump, or another auxiliary drive.

ENSURE BELTS ARE IN GOOD CONDITION. ONCE INSPECTED IF THIS VIBRATION REMAINS PRESENT, IT IS LIKELY A NEARBY UNIT HAS ELEVATED VIBRATION THAT IS TRANSFERRING TO THIS MACHINE. TRANSMITTED VIBRATION CAN BE REDUCED BY ENSURING THE UNIT IS SECURED ON A SOLID FOUNDATION. IF THIS VIBRATION CONTINUES TO INCREASE, A NEARBY UNIT MAY BE DEGRADING AND SHOULD BE LOCATED AND ADDRESSED.

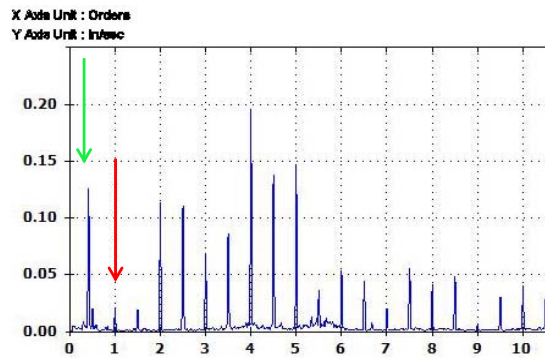
Fluke Location 3 Tangent

This elevated .4x is present throughout the unit as seen in the fft graph below. The green arrow marks the .4x vibration around .12 ips, while the red arrow marks the normal .5x peak at a low amplitude.

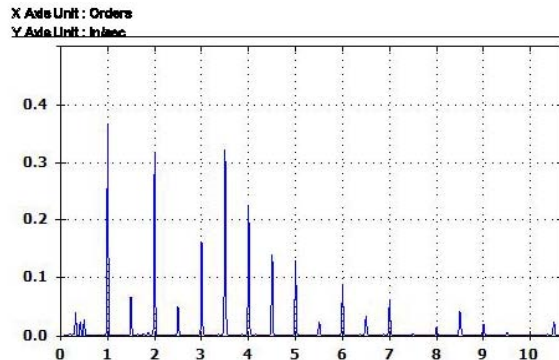
Fluke Location 1 Tangent

Low frequency vibration remains present when unit is under load as seen in the fft graph below.

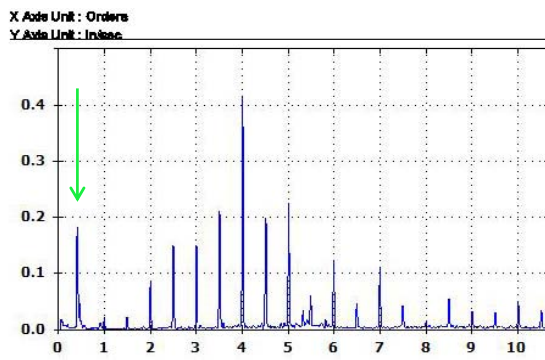
Fluke Location 3 Tangent

Low frequency vibration increases to nearly .2 ips as seen marked by the arrow below.

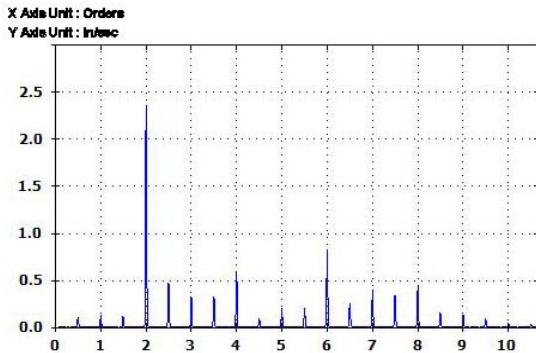
Fluke Location 1 Tangent

All vibration is synchronous to running speed as seen in the fft graph below. (Peaks are only found at multiples of .5x and 1x).

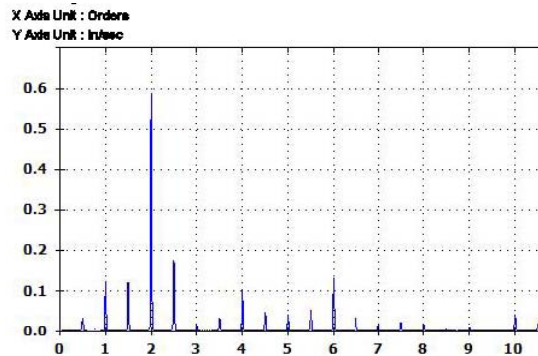
Fluke Location 3 Tangent

All vibration is synchronous to running speed as seen in the fft graph below. (Peaks are only found at multiples of .5x and 1x).

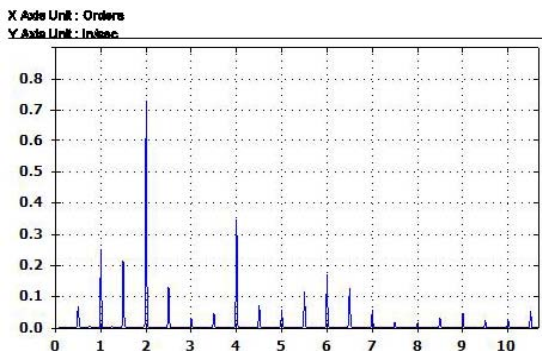
Fluke Location 1 Tangent

All vibration is synchronous to running speed as seen in the fft graph below. (Peaks are only found at multiples of .5x and 1x).

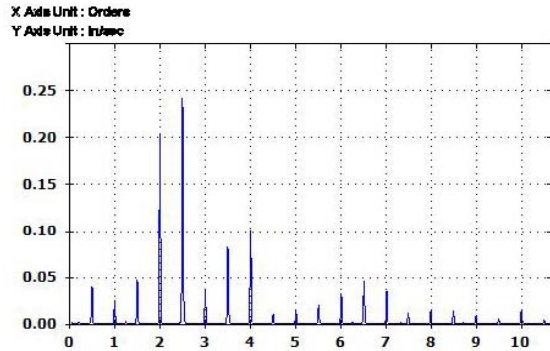
Fluke Location 3 Tangent

All vibration is synchronous to running speed as seen in the fft graph below. (Peaks are only found at multiples of .5x and 1x).
