INFRARED ANALYSIS SURVEY REPORT

Sample Client

Facility A

DATA COLLECTED: December 2013

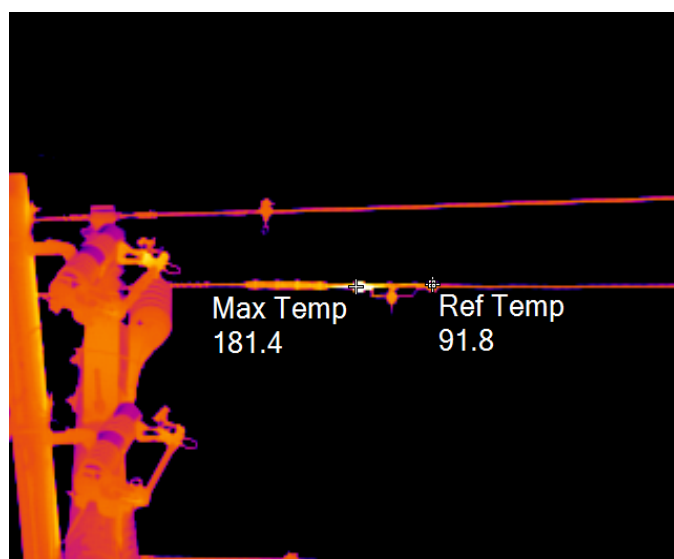
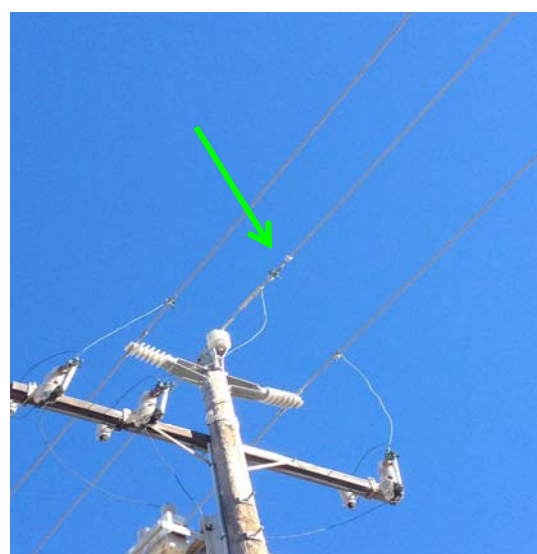
Inspection Date:	12/12/13	Location	
Equipment	Pole E34 (Above the Old Field Gas Compressor)	Equipment Name:	“U” Clamp Connection
Recommended Action	Inspect and clean this connection.	Potential Problem	Excessive Resistance
Emissivity:	0.94	Repair Priority:	Moderate
Camera Manufacturer	Fluke Thermography	Inspected By:	Justin Hanscom

Comments: This middle line has a “U” clamp connection that indicates a defective condition resulting in elevated thermal pattern, this appears to be a result of excessive resistance at the mechanical connection. This is a new defect.

Name	Temperature
Ambient Temperature	65°F
Defect Max Temperature	181.4°F
Reference Temperature	91.8°F
Defect vs. Reference Delta Temp.	89.6°F
Defect Rise Above Ambient	116.4°F

Recommendations: Connection needs to be cleaned and inspected for any further damage. This should be addressed ASAP as delta temp indicates 90°F rise.

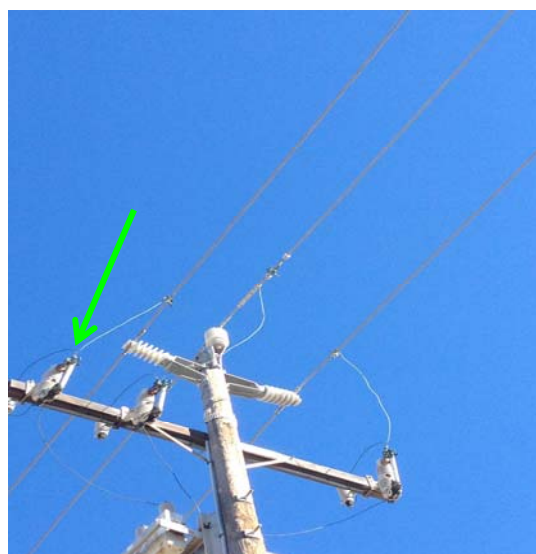
Inspection Date:	12/12/13	Location	
Equipment	Pole E34 (Above the Old Field Gas Compressor)	Equipment Name:	Left Fuse
Recommended Action	Inspect and clean this connection.	Potential Problem	Loose or corroded connection
Emissivity:	0.94	Repair Priority:	Minor
Camera Manufacturer	Fluke Thermography	Inspected By:	Justin Hanscom

Comments: This left fuse has a top connection defect. It has been reported on multiple times and has continued to increase in temperature.

Name	Temperature
Ambient Temperature	65°F
Defect Max Temperature	116.7°F
Reference Temperature	89.3°F
Defect vs. Reference Delta Temp.	27.4°F
Defect Rise Above Ambient	51.7°F

Recommendations: Connection needs to be cleaned and inspected for any further damage. Also fuse should be inspected as well.

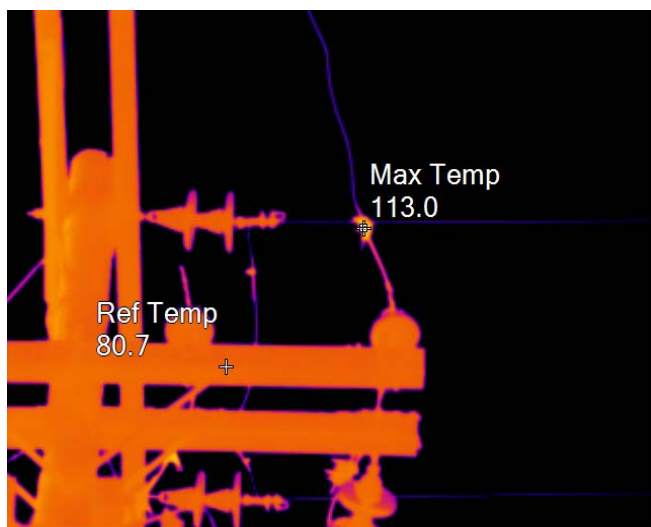
East Side Field Pole E-54

Inspection Date:	12/12/13	Location	
Equipment	Pole E-54	Equipment Name:	Left line clamp connection
Recommended Action	Inspect and clean connection.	Potential Problem	Loose or corroded connection
Emissivity:	0.94	Repair Priority:	Minor
Camera Manufacturer	Fluke Thermography	Inspected By:	Justin Hanscom

Comments: This left side line has a thermal pattern on the clamp connection consistent with excessive resistance due to a loose or corroded connection.

Name	Temperature
Ambient Temperature	65°F
Defect Max Temperature	113°F
Reference Temperature	80.7°F
Defect vs. Reference Delta Temp.	32.3°F
Defect Rise Above Ambient	48°F

Recommendations: Connection needs to be cleaned and inspected for any further damage. Verify all clamp connections are clean.
