# VIBRATION ANALYSIS REPORT

## AB CONTROL SYSTEMS

AIR HANDLER UNITS #1 AND #2

DATA COLLECTED: 1/13/14

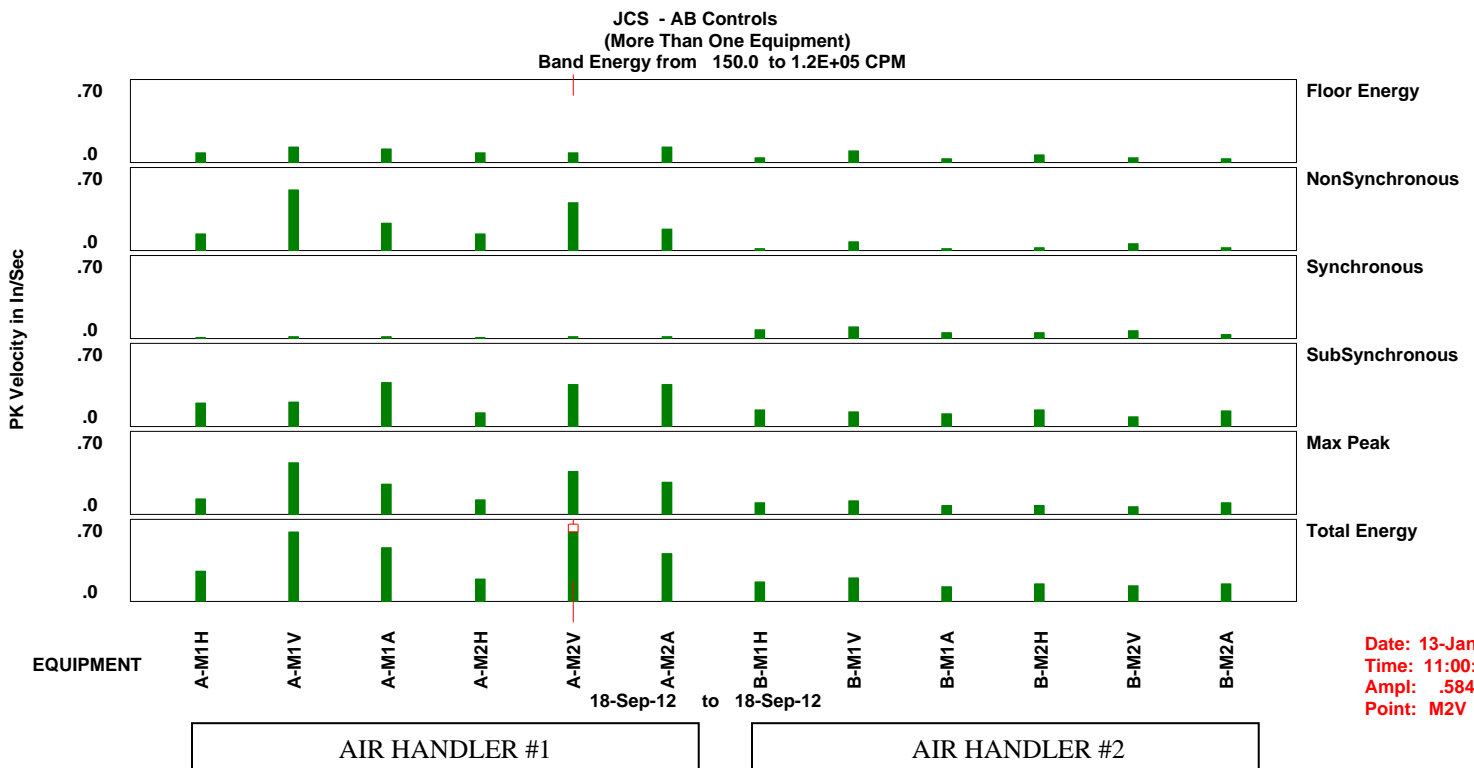
Date: 13-Jan-14  
Time: 11:00:49  
Ampl: .584  
Point: M2V

In looking at the motor data, air handler unit #1 shows some elevated vibration on the motor in the vertical and axial planes that is excited by fan shaft speed and harmonics. In the graph below the vibration energy is shown as an overall value and then is also separated into separate bands such as peak energy, synchronous and so on. It can be observed that the vertical data points on unit A (which is unit #1) shows overall energy that exceeds .58 inches per second velocity. This is shown to be in the non-synchronous band because its source is from the fan shaft speed and not from motor speed.

Inspect unit #1 and verify alignment is within tolerances. Inspect motor base for loose or cracked support bolting.

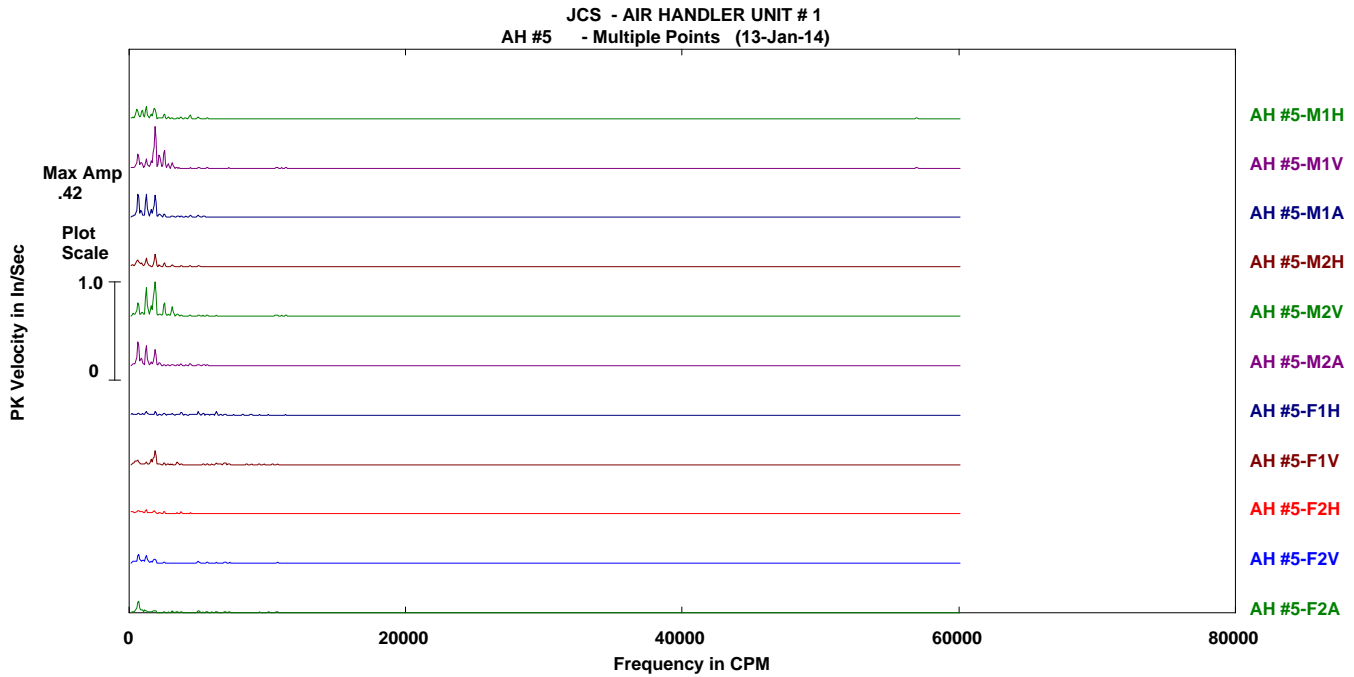
In the following graph the vibration data on unit five is shown on motor and fan data points which shows that there is little energy on the fan shaft and virtually all energy is on the motor points.

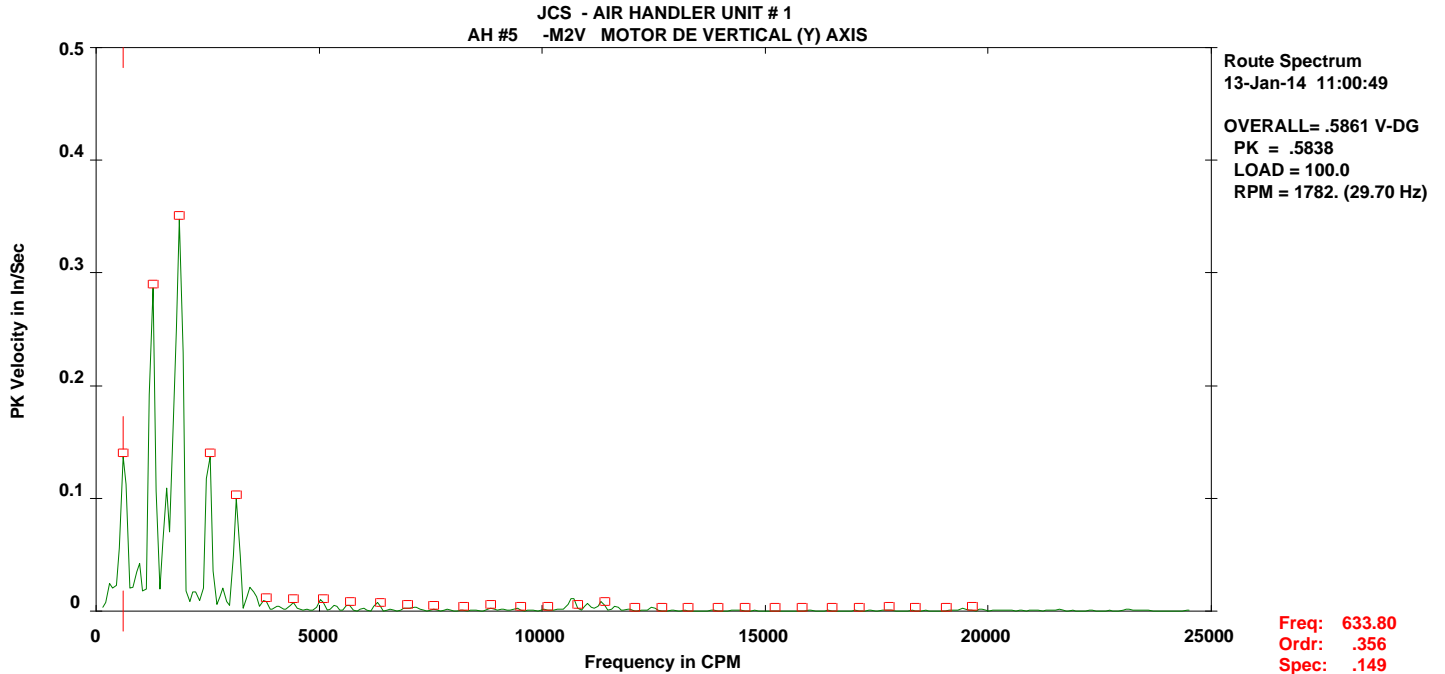
The FFT spectrum below shows the motor drive end vertical data point detail with peaks marked at 633 counts per minute (CPM) and harmonics. **Due to the presence of axial vibration coupled with vertical energy, a misalignment of the fan to motor sheave is likely.** As a secondary concern, a loose motor base may be present but less likely as there would be little reason for the radial energy generated by looseness to excite the motor axially.

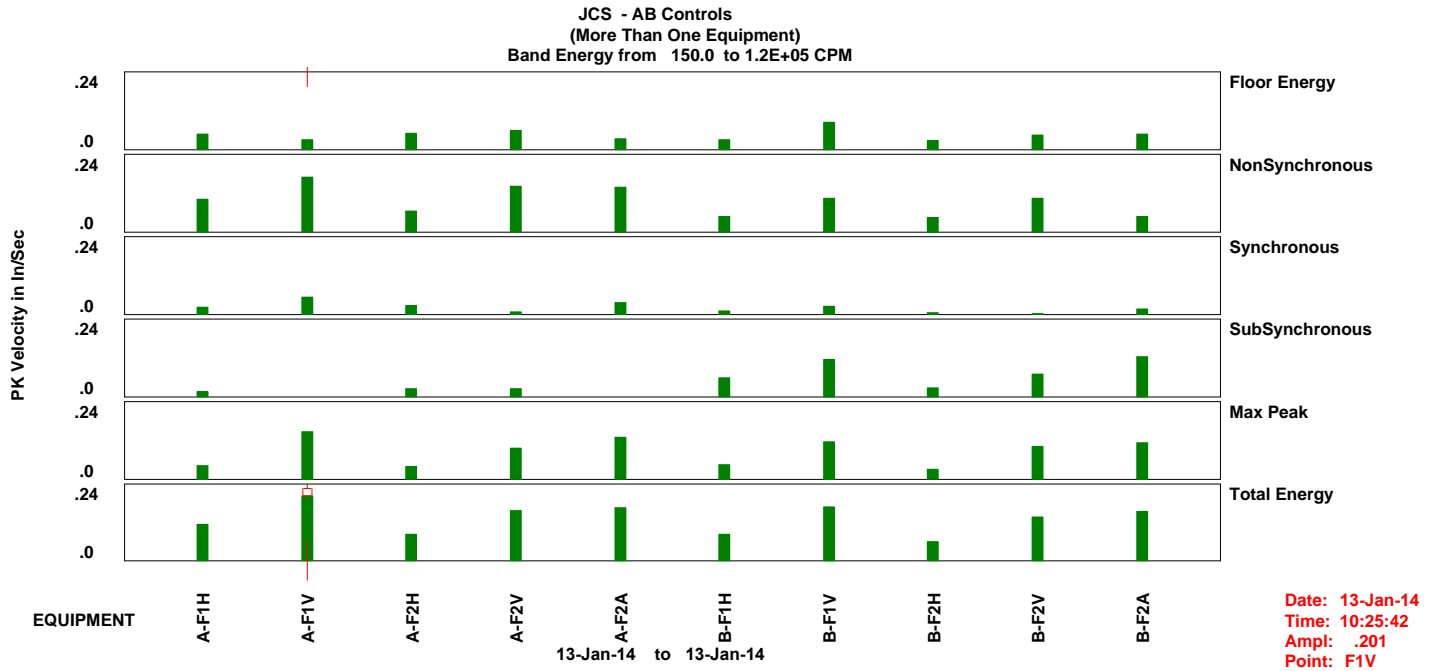
With regards to the fan energy on both units there is no indication of any excessive vibration. The energy graph below of both fans shows relatively even vibration with maximum levels less than .21 ips.

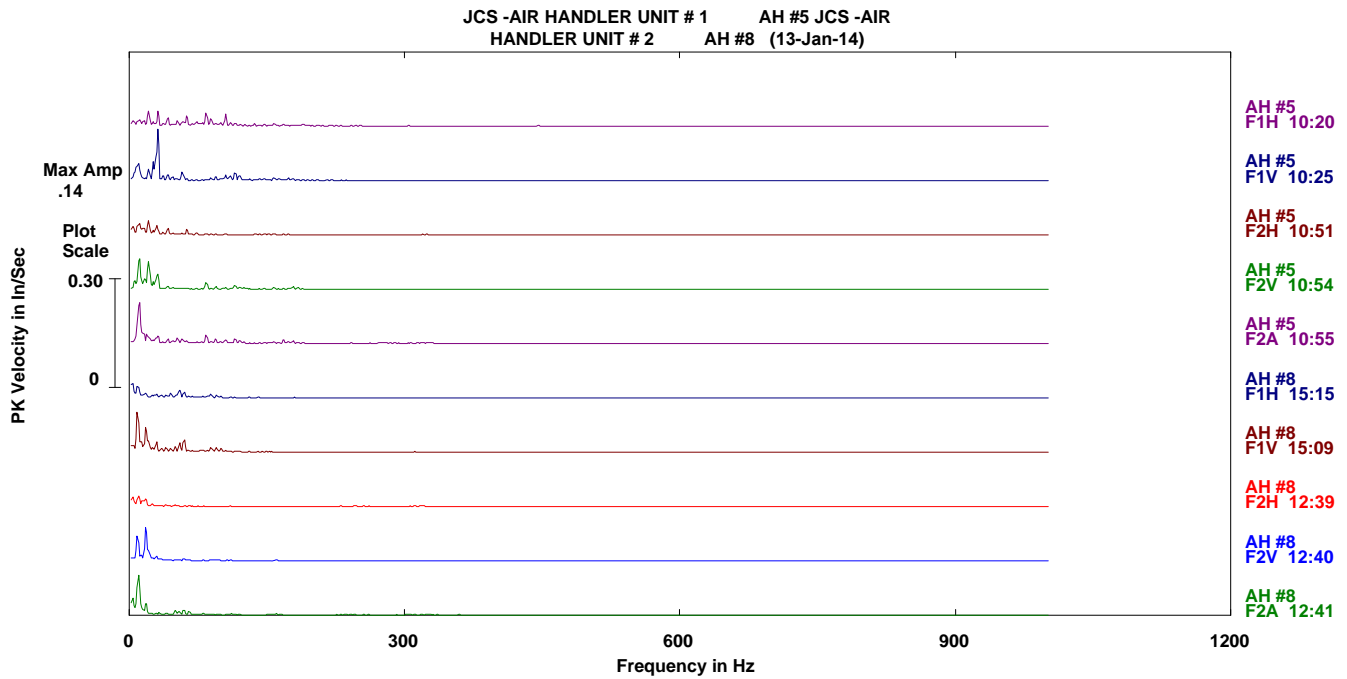
As a second illustration the FFT graph of all fan data on both units is shown below in velocity.

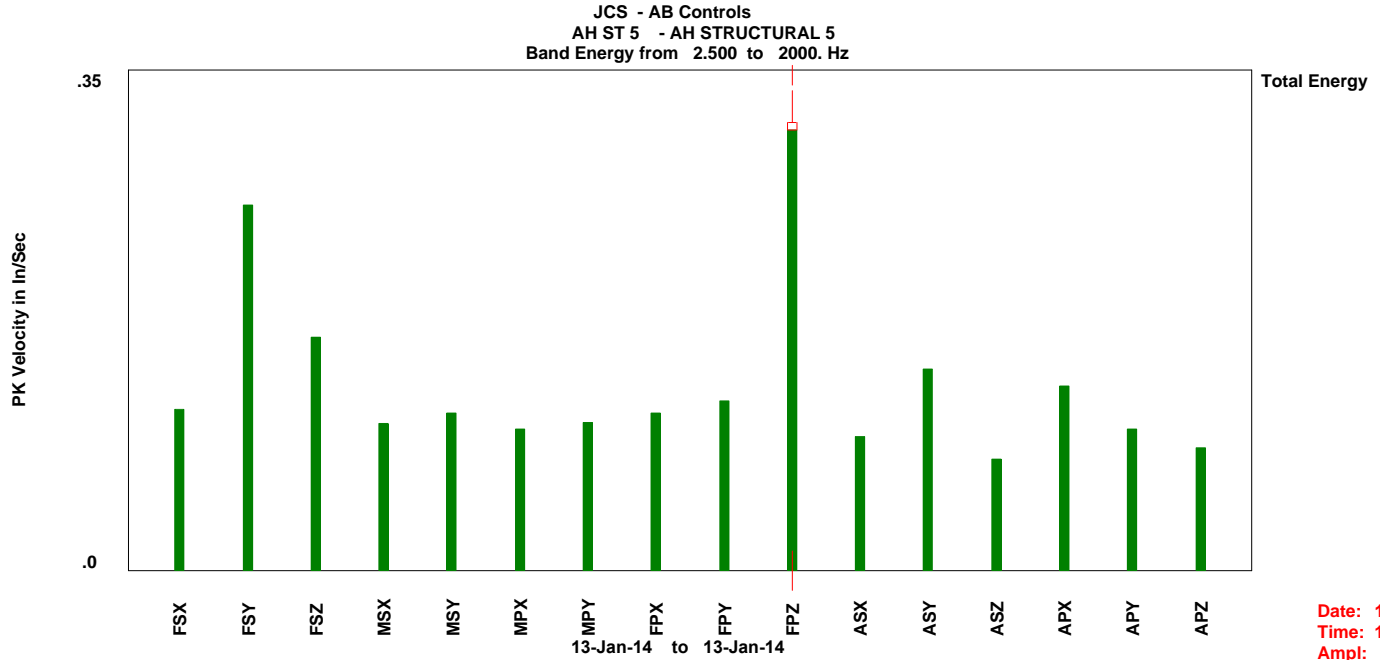
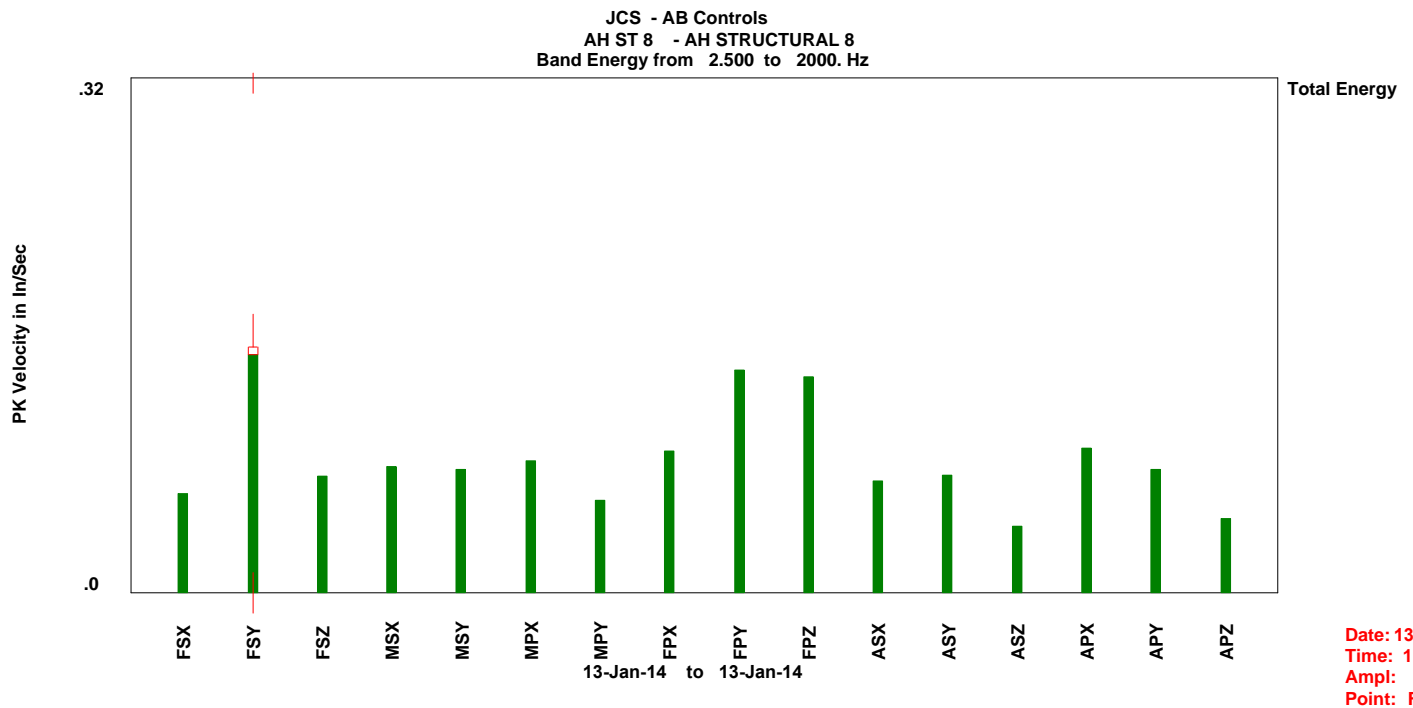
With respect to the structure the following graphs show an energy profile. Unit #1 is illustrated in the top graph and shows some elevated energy on a few readings which is at 1855 CPM, or 3x fan shaft speed. The bottom graph of Unit #2 indicates an even energy profile.

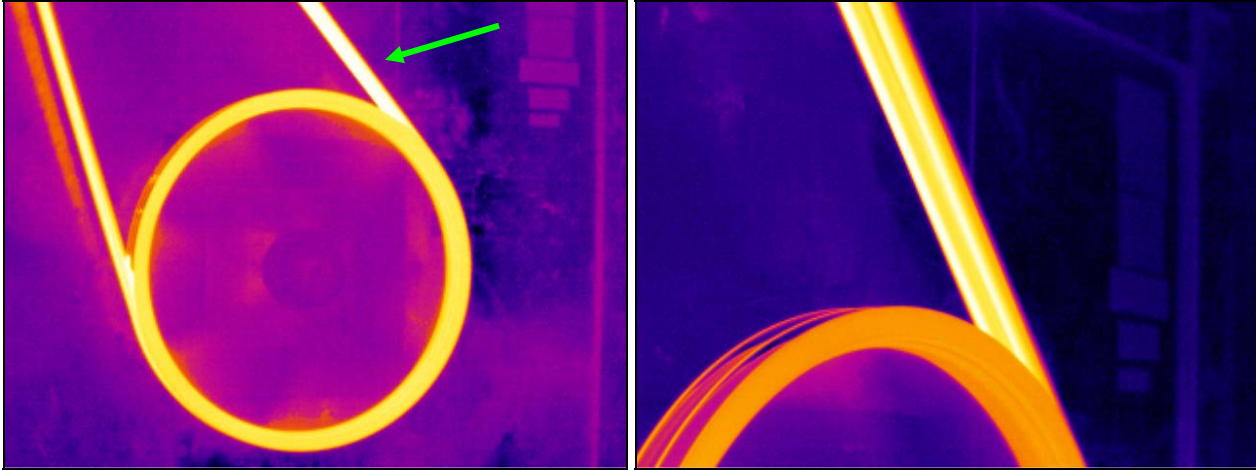
While onsite the CMS technician inspected this unit with a Fluke Ti32 Thermal Imaging Camera. The infrared images below support the vibration findings that unit #1 has some misalignment or potential excessive wear on the fan sheave.
