INFRARED ANALYSIS SURVEY REPORT

SAMPLE CLIENT REPORT

Facility A

DATA COLLECTED: December 2015

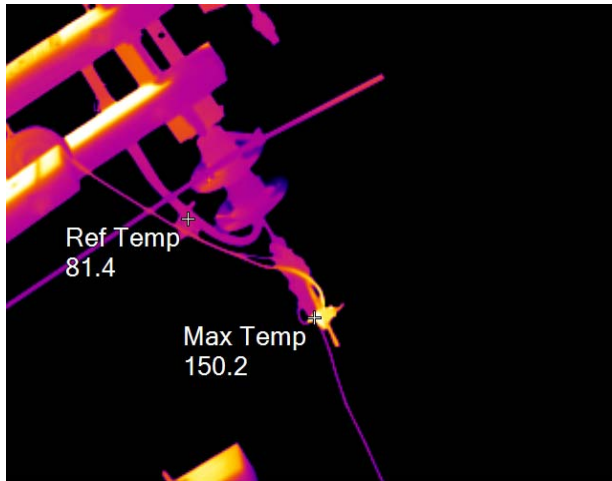
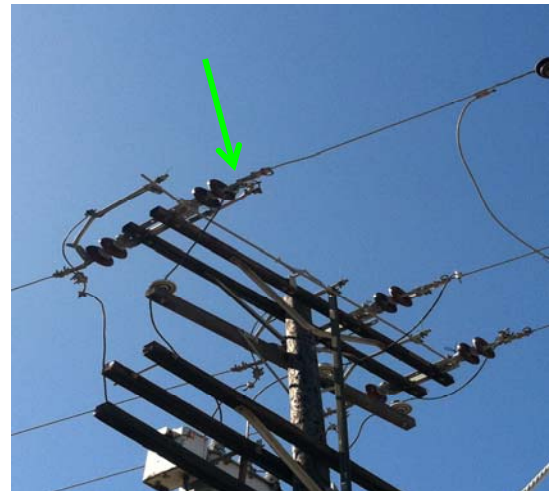
Pole E3 Next To The Reclosure

Inspection Date:	12/12/13	Location	
Equipment	Pole E3 Next to the Reclosure	Equipment Name:	Hot Line Connection
Recommended Action	Clean and tighten connection.	Potential Problem	Loose or corroded connection
Emissivity:	0.94	Repair Priority:	Moderate
Camera Manufacturer	Fluke Thermography	Inspected By:	Justin Hanscom

Comments: This left side line has a hot clamp connection defect. It has been reported on multiple times and has continued to increase in temperature.

Name	Temperature
Ambient Temperature	65°F
Defect Max Temperature	150.2°F
Reference Temperature	81.4°F
Defect vs. Reference Delta Temp.	68.8°F
Defect Rise Above Ambient	85.2°F

Recommendations: Connection needs to be cleaned and inspected for any further damage.

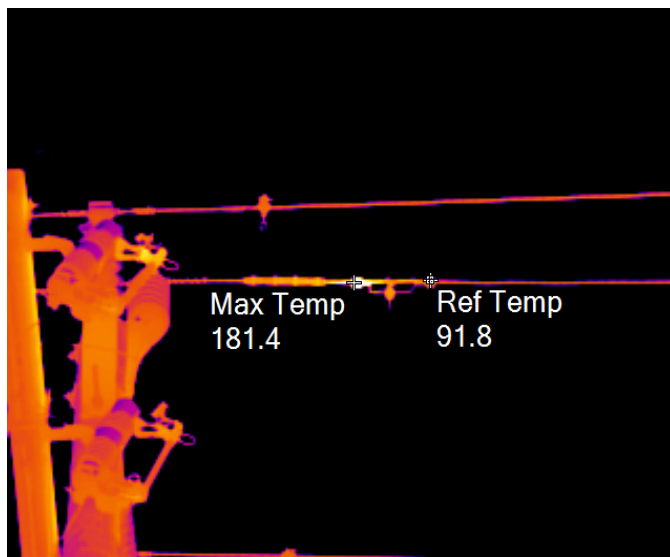
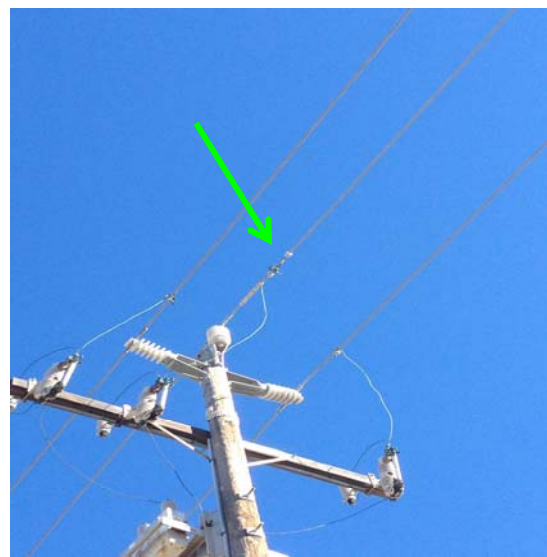
Inspection Date:	12/12/13	Location	
Equipment	Pole E34 (Above the Old Field Gas Compressor)	Equipment Name:	"U" Clamp Connection
Recommended Action	Inspect and clean this connection.	Potential Problem	Excessive Resistance
Emissivity:	0.94	Repair Priority:	Moderate
Camera Manufacturer	Fluke Thermography	Inspected By:	Justin Hanscom

Comments: This middle line has a "U" clamp connection that indicates a defective condition resulting in elevated thermal pattern, this appears to be a result of excessive resistance at the mechanical connection. This is a new defect.

Name	Temperature
Ambient Temperature	65°F
Defect Max Temperature	181.4°F
Reference Temperature	91.8°F
Defect vs. Reference Delta Temp.	89.6°F
Defect Rise Above Ambient	116.4°F

Recommendations: Connection needs to be cleaned and inspected for any further damage. This should be addressed ASAP as delta temp indicates 90°F rise.

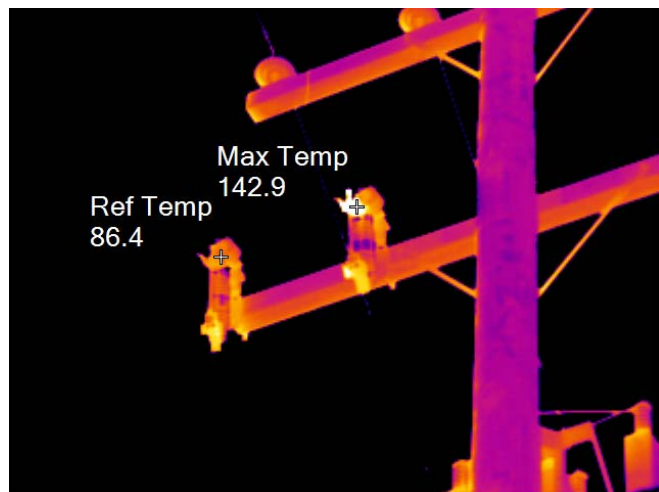
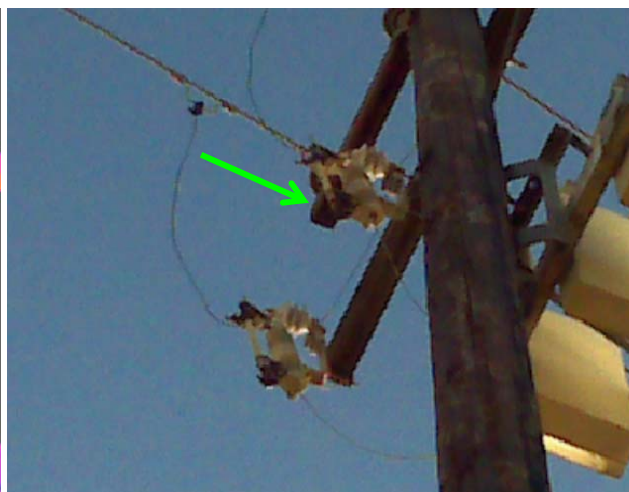
East Side Field Pole E-57

Inspection Date:	12/12/13	Location	
Equipment	Pole E-57 (At the West Part of the T-280 Crude Oil Tank)	Equipment Name:	Line Side B Phase Connection
Recommended Action	Inspect and clean connection and fuse.	Potential Problem	Loose or corroded connection.
Inspected By:	Justin Hanscom	Repair Priority:	Minor

Comments: This middle fuse has elevated thermal pattern on the line side B phase connection. It has been reported on multiple times and has continued to elevate in temperature.

Name	Temperature
Ambient Temperature	65°F
Defect Max Temperature	142.9°F
Reference Temperature	86.4°F
Defect vs. Reference Delta Temp.	56.5°F
Defect Rise Above Ambient	77.9°F

Recommendations: Connection needs to be cleaned and inspected for any further damage. Also fuse should be inspected as well.

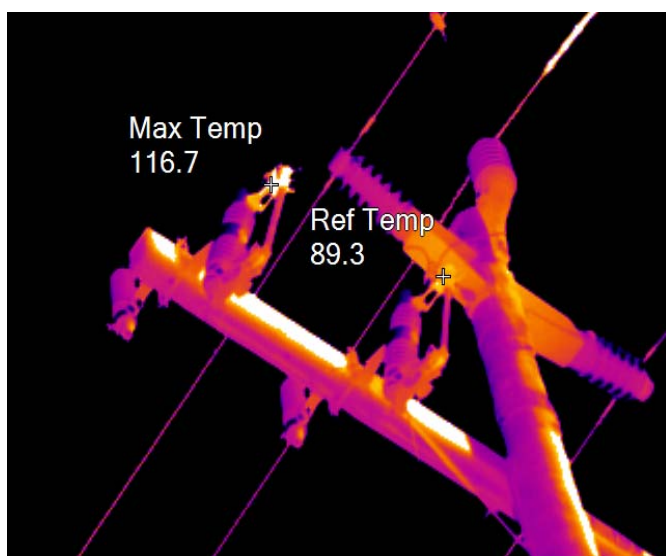
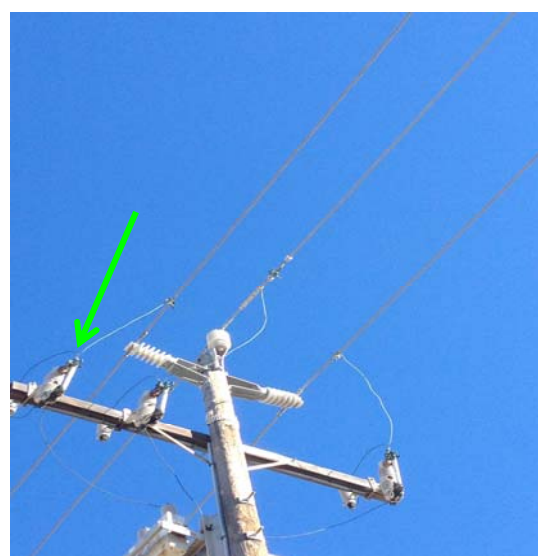
Inspection Date:	12/12/13	Location	
Equipment	Pole E34 (Above the Old Field Gas Compressor)	Equipment Name:	Left Fuse
Recommended Action	Inspect and clean this connection.	Potential Problem	Loose or corroded connection
Emissivity:	0.94	Repair Priority:	Minor
Camera Manufacturer	Fluke Thermography	Inspected By:	Justin Hanscom

Comments: This left fuse has a top connection defect. It has been reported on multiple times and has continued to increase in temperature.

Name	Temperature
Ambient Temperature	65°F
Defect Max Temperature	116.7°F
Reference Temperature	89.3°F
Defect vs. Reference Delta Temp.	27.4°F
Defect Rise Above Ambient	51.7°F

Recommendations: Connection needs to be cleaned and inspected for any further damage. Also fuse should be inspected as well.

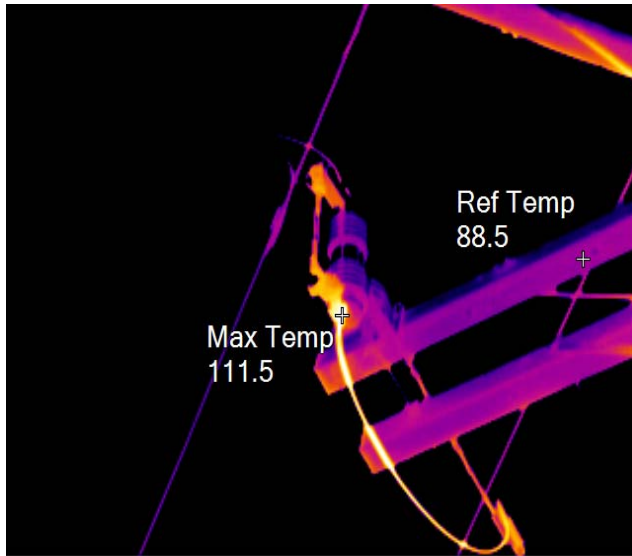
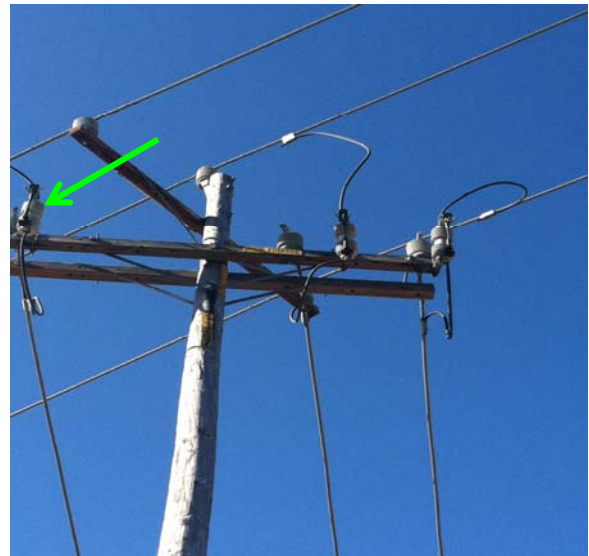
Pole 135528

Inspection Date:	12/12/13	Location	
Equipment	Pole 135528. (At the North Part of the T-280 Crude Oil Tank)	Equipment Name:	Left Fuse
Recommended Action	Clean and tighten connection.	Potential Problem	Loose or corroded connection
Emissivity:	0.94	Repair Priority:	Minor
Camera Manufacturer	Fluke Thermography	Inspected By:	Justin Hanscom

Comments: This left fuse has a bottom connection defect. It has been reported on multiple times and has continued to elevate in temperature.

Name	Temperature
Ambient Temperature	65°F
Defect Max Temperature	111.5°F
Reference Temperature	88.5°F
Defect vs. Reference Delta Temp.	23°F
Defect Rise Above Ambient	46.5°F

Recommendations: Connection needs to be cleaned and inspected for any further damage. Also inspect fuse.

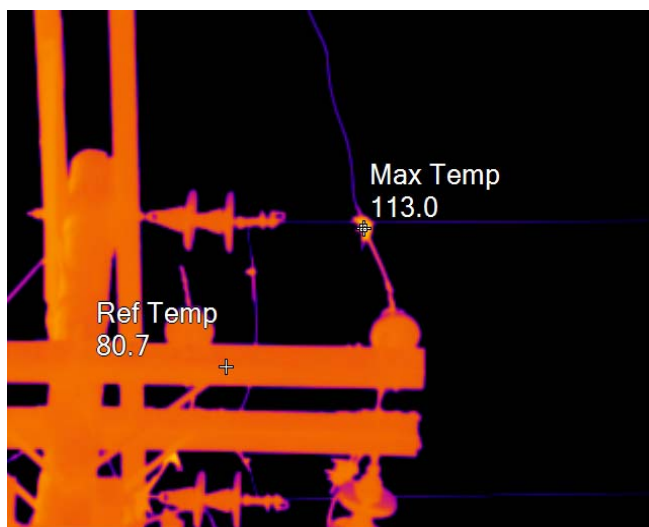
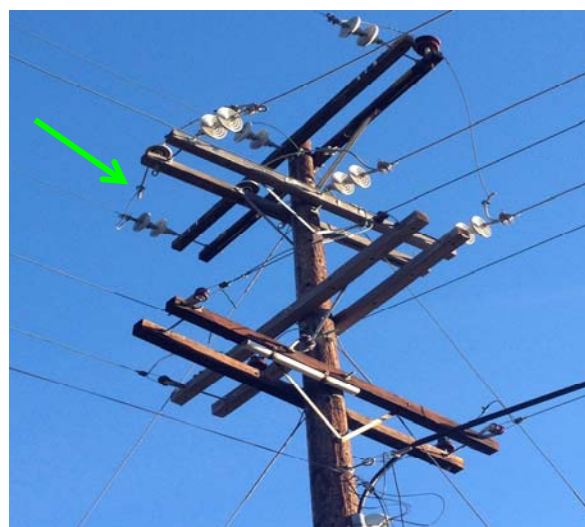
East Side Field Pole E-54

Inspection Date:	12/12/13	Location	
Equipment	Pole E-54	Equipment Name:	Left line clamp connection
Recommended Action	Inspect and clean connection.	Potential Problem	Loose or corroded connection
Emissivity:	0.94	Repair Priority:	Minor
Camera Manufacturer	Fluke Thermography	Inspected By:	Justin Hanscom

Comments: This left side line has a thermal pattern on the clamp connection consistent with excessive resistance due to a loose or corroded connection.

Name	Temperature
Ambient Temperature	65°F
Defect Max Temperature	113°F
Reference Temperature	80.7°F
Defect vs. Reference Delta Temp.	32.3°F
Defect Rise Above Ambient	48°F

Recommendations: Connection needs to be cleaned and inspected for any further damage. Verify all clamp connections are clean.

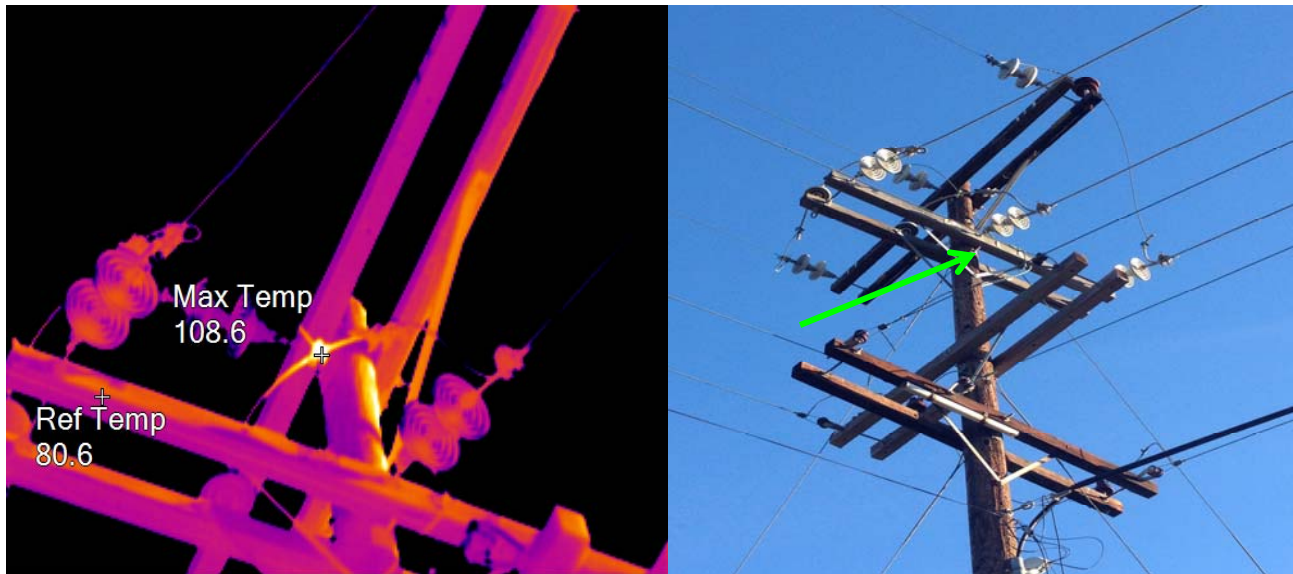
East Side Field Pole E-54

Inspection Date:	12/12/13	Location	
Equipment	Pole E-54	Equipment Name:	Middle line clamp connection
Recommended Action	Inspect and clean connection.	Potential Problem	Loose or corroded connection
Emissivity:	0.94	Repair Priority:	Minor
Camera Manufacturer	Fluke Thermography	Inspected By:	Justin Hanscom

Comments: This middle line has a thermal pattern on the clamp connection consistent with excessive resistance. Typically this is a result of a loose or corroded clamp connection.

Name	Temperature
Ambient Temperature	65°F
Defect Max Temperature	108.6°F
Reference Temperature	80.6°F
Defect vs. Reference Delta Temp.	28°F
Defect Rise Above Ambient	43.6°F

Recommendations: Connection needs to be cleaned and inspected for any further damage.

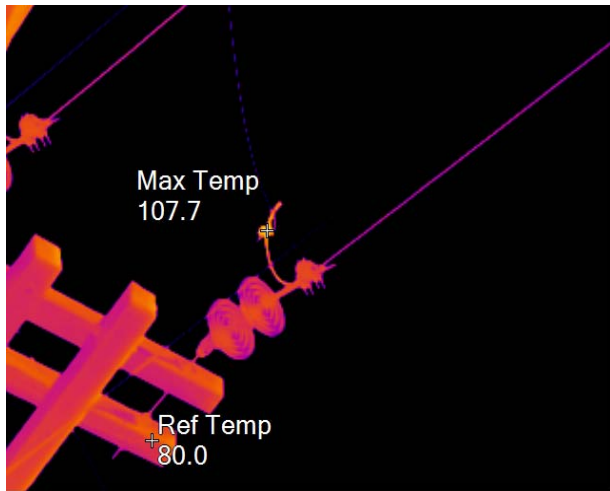
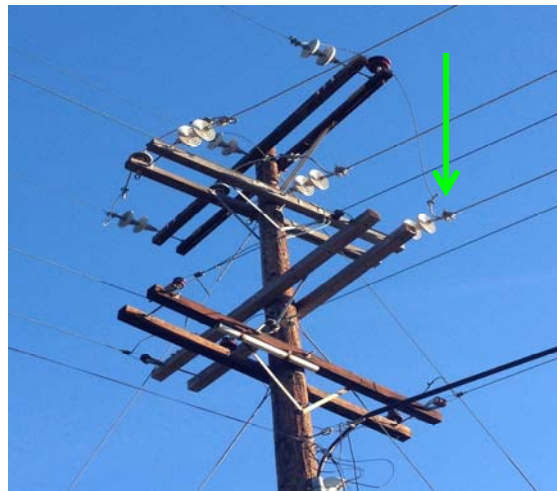
East Side Field Pole E-54

Inspection Date:	12/12/13	Location	
Equipment	Pole E-54	Equipment Name:	Middle line clamp connection
Recommended Action	Inspect and clean connection.	Potential Problem	Loose or corroded connection
Emissivity:	0.94	Repair Priority:	Minor
Camera Manufacturer	Fluke Thermography	Inspected By:	Justin Hanscom

Comments: This middle line has a hot clamp connection defect.

Name	Temperature
Ambient Temperature	65°F
Defect Max Temperature	107.7°F
Reference Temperature	80°F
Defect vs. Reference Delta Temp.	27.7°F
Defect Rise Above Ambient	42.7°F

Recommendations: Connection needs to be cleaned and inspected for any further damage.

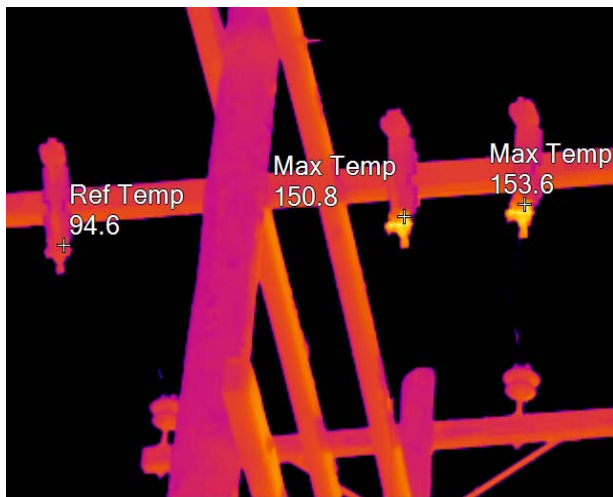
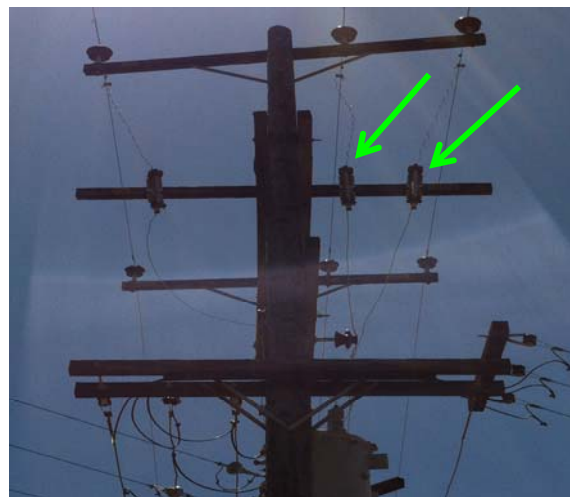
Inspection Date:	12/26/13	Location	
Equipment	Pole W-19	Equipment Name:	Load side fuses
Recommended Action	Inspect and clean connections. Ensure proper load.	Potential Problem	Elevated thermal pattern may be load related but warrants monitoring.
Emissivity:	0.94	Repair Priority:	Minor
Camera Manufacturer	Fluke Thermography	Inspected By:	Justin Hanscom

Comments: Load side fuses have elevated thermal pattern that may be load related but warrant inspection. It has been reported on and has continued to increase in temperature.

Name	Temperature
Ambient Temperature	65°F
Defect Max Temperature	153.6°F
Reference Temperature	94.6°F
Defect vs. Reference Delta Temp.	59°F
Defect Rise Above Ambient	88.6°F

Recommendations: Connections need to be cleaned and inspected for any further damage. Also inspect fuse.

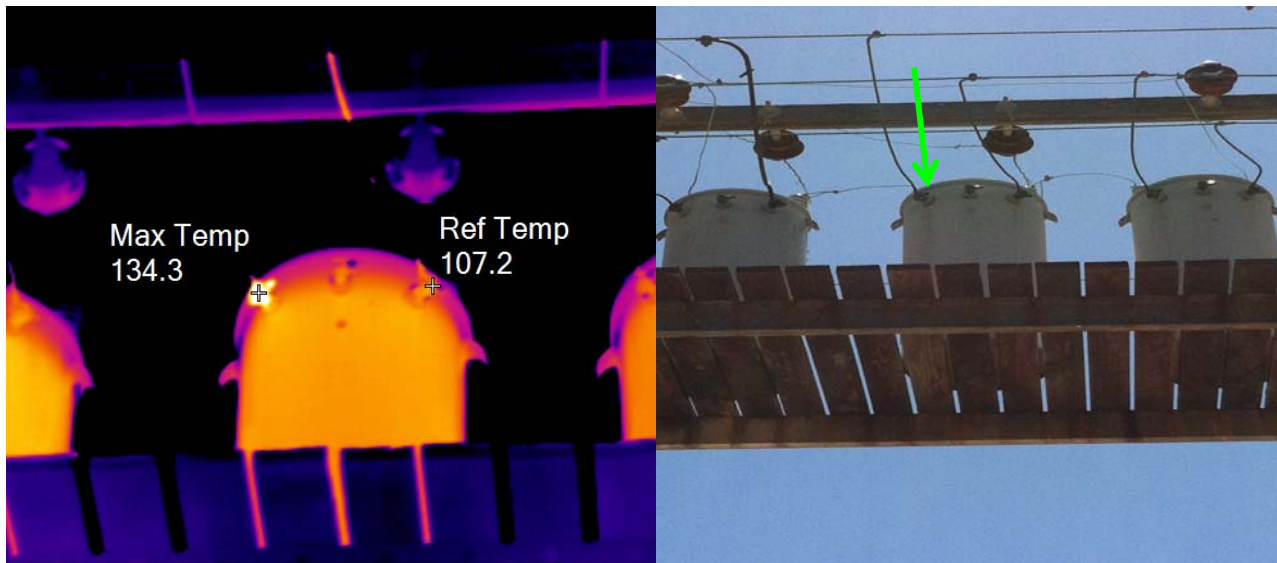
Inspection Date:	12/26/13	Location	
Equipment	Pole W-23	Equipment Name:	Middle transformer, Secondary tap connection
Recommended Action	Inspect and clean connection.	Potential Problem	Loose or corroded connection.
Emissivity:	0.94	Repair Priority:	Minor
Camera Manufacturer	Fluke Thermography	Inspected By:	Justin Hanscom

Comments: This center transformer has a thermal pattern consistent with a loose or corroded secondary tap connection.

Name	Temperature
Ambient Temperature	65°F
Defect Max Temperature	134.3°F
Reference Temperature	107.2°F
Defect vs. Reference Delta Temp.	27.1°F
Defect Rise Above Ambient	69.3°F

Recommendations: Connection needs to be cleaned and inspected for any further damage.
