Prepared For: Sample Client
Facility : Power Gen Facility
Equipment: WSAC Exchanger Cooling Fan
Location: WSAC CCW SYSTEM

Component: WSAC FIN FAN COOLER
Description: 1H Motor Drive Sheave
View aspect: Direct
Severity: Moderate

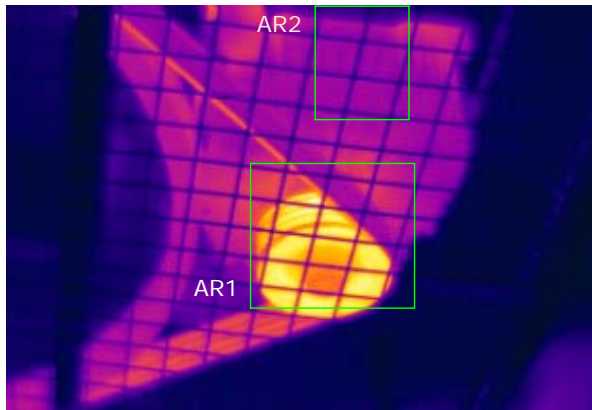
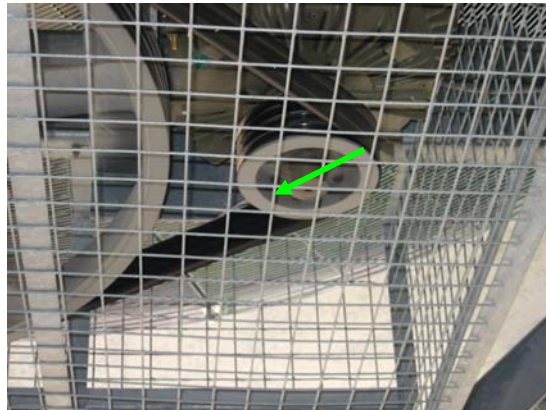
Table with 2 columns: Information (Image Date, Image Time, Image File name, Emissivity, Reflected Temperature, Defect Max. Temperature, Reference Max. Temperature, Defect vs. reference delta temp., Defect rise above ambient) and Values (February 20, 2016, 1:41:46 PM, A0729286.IMG, 0.95, 67.0 °F, 141.8 °F, 106.6 °F, 35.2 °F, 74.8 °F).

Comments: Excessive temperature on motor sheave.
Recommend: Perform vibration analysis on motor to determine source of problem. Not a typical loose belt signature as the belt temperature is not excessive.
