ULTRASOUND EXCEPTION REPORT

SAMPLE CUSTOMER

SAMPLE LOCATION

Data Collected: April 2015

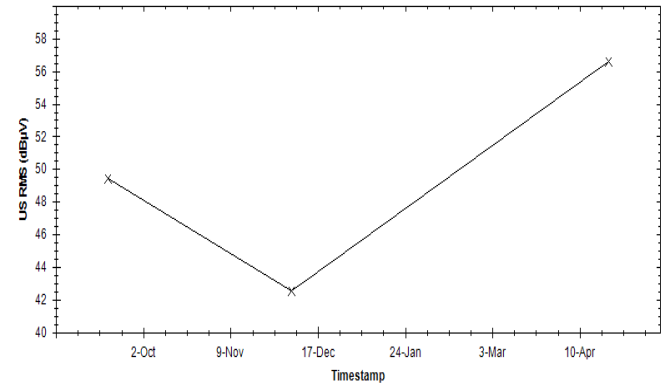
Machine name:	STG HYDRAULIC PUMP A	Location:	STG
Data collected:	April 10, 2015	STATUS:	DEFECTIVE reliability is poor

OBSERVATIONS: LEVELS CONTINUE TO INCREASE AND MAY BE DUE TO LACK OF LUBRICATION. VIBRATION INDICATES INTERNAL WEAR OR LOOSENESS MAY BE PRESENT. THE TREND TO THE RIGHT IS OF THE PUMP OUTBOARD.

RECOMMENDATIONS: ENSURE MOTOR INBOARD AND PUMP BEARINGS ARE LUBRICATED. MONITOR MONTHLY WITH VIBRATION.

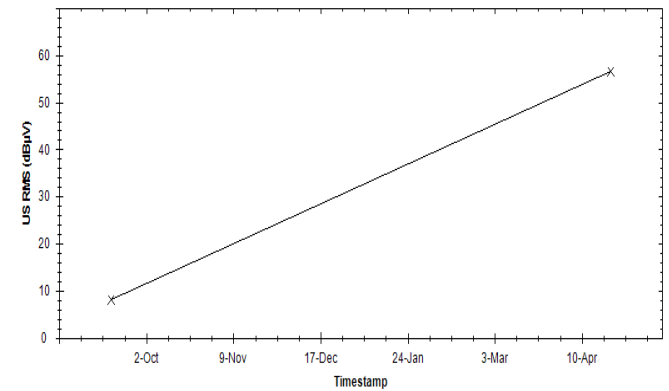
Machine name:	STG HYDRAULIC PUMP B	Location:	STG
Data collected:	April 10, 2015	STATUS:	DEFECTIVE reliability is poor

OBSERVATIONS: ULTRASOUND VALUES REMAIN ELEVATED ON THIS UNIT. VIBRATION INDICATES AN INBOARD MOTOR BEARING DEFECT IS PRESENT IN EARLY STAGES. THE TREND TO THE RIGHT IS OF THE PUMP OUTBOARD.

RECOMMENDATIONS: ENSURE PUMP AND MOTOR BEARINGS ARE LUBRICATED. MONITOR BEARING DEFECT WITH VIBRATION.

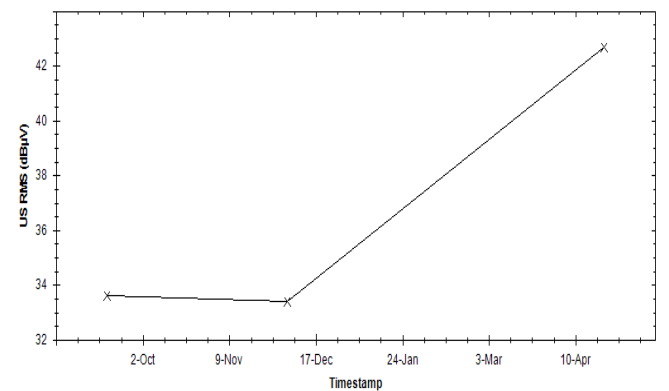
Machine name:	BOILER FEEDWATER PUMP 101-A	Location:	UNIT A
Data collected:	April 10, 2015	STATUS:	ALERT defects may be present

OBSERVATIONS: LEVELS ARE INCREASING AGAIN AND IS LIKELY DUE TO LACK OF LUBRICATION. THE TREND TO THE RIGHT IS OF THE GEARBOX OUTBOARD. CURRENT VIBRATION IS NORMAL.

RECOMMENDATIONS: ENSURE GEARBOX BEARINGS ARE PROPERLY LUBRICATED.

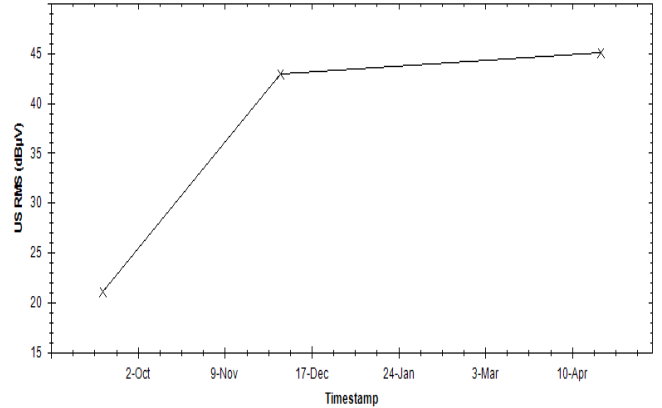
Machine name:	STG GLAND STEAM BLOWER B	Location:	STG
Data collected:	April 10, 2015	STATUS:	ALERT defects may be present

ULTRASOUND REMAINS ELEVATED. VIBRATION INDICATES THIS UNIT HAS A MOTOR BEARING DEFECT IN EARLY TO MODERATE STAGES. THE TREND TO THE RIGHT IS OF THE MOTOR OUTBOARD.

MONITOR WITH VIBRATION.

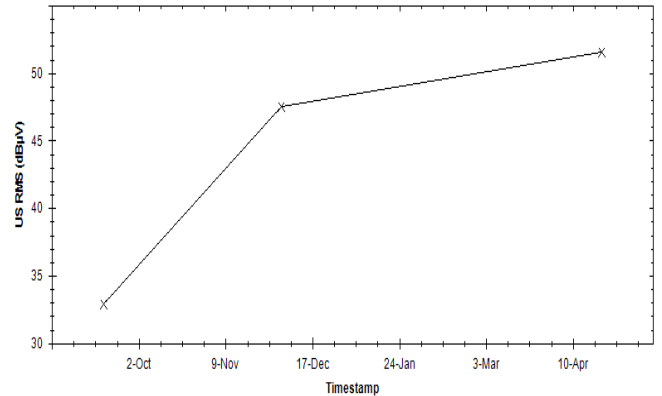
Machine name:	1A LUBE OIL MIST SEPARATION MOTOR 1	Location:	UNIT A
Data collected:	April 10, 2015	STATUS:	ALERT defects may be present

ULTRASOUND REMAINS ELEVATED. VIBRATION INDICATES A MOTOR BEARING DEFECT IS PRESENT IN EARLY STAGES.

ENSURE MOTOR BEARINGS ARE LUBRICATED AND MONITOR WITH VIBRATION.

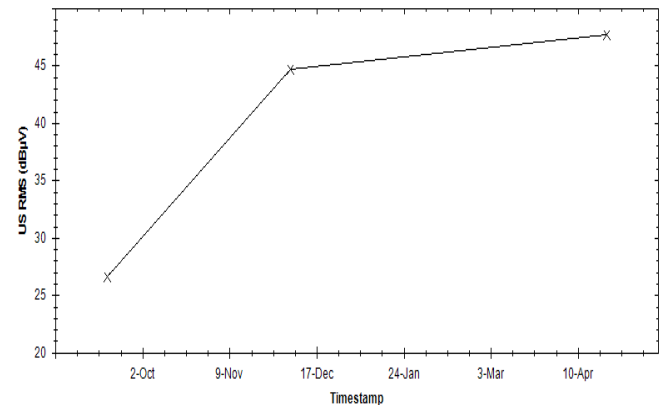
Machine name:	1B AUX HYDRAULIC PUMP 2	Location:	UNIT B
Data collected:	April 10, 2015	STATUS:	ALERT defects may be present

ELEVATED ULTRASOUND LEVELS MAY BE DUE TO LACK OF LUBRICATION. THE TREND TO THE RIGHT IS OF THE MOTOR INBOARD. VIBRATION LEVELS ARE NORMAL.

ENSURE MOTOR INBOARD BEARING IS LUBRICATED.

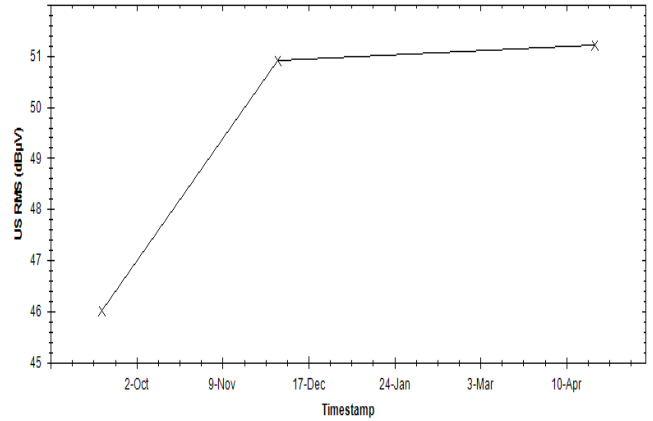
Machine name:	1B DUCT BURNER FAN B	Location:	UNIT B
Data collected:	April 10, 2015	STATUS:	ALERT defects may be present

OBSERVATIONS: ULTRASOUND LEVELS REMAIN ELEVATED AND MAY BE DUE TO LACK OF LUBRICATION. CURRENT VIBRATION IS NORMAL. THE TREND TO THE RIGHT IS OF THE MOTOR OUTBOARD.

RECOMMENDATIONS: ENSURE MOTOR OUTBOARD BEARING IS LUBRICATED.

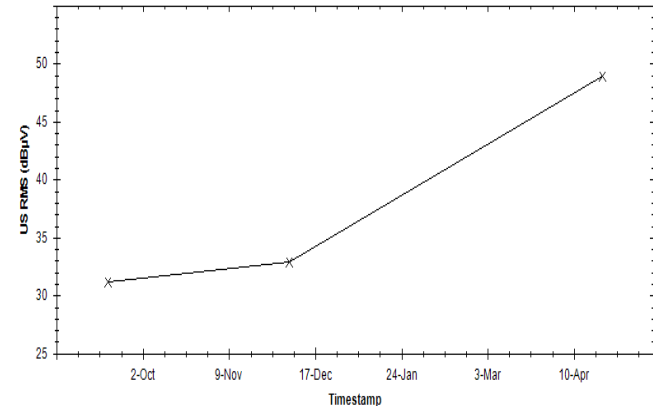
Machine name:	1B EXHAUST FRAME BLOWER 2	Location:	UNIT B
Data collected:	April 10, 2015	STATUS:	ALERT defects may be present

OBSERVATIONS: ULTRASOUND LEVELS MAY BE ELEVATED DUE TO LACK OF LUBRICATION. CURRENT VIBRATION IS NORMAL. THE TREND TO THE RIGHT IS OF THE MOTOR INBOARD.

RECOMMENDATIONS: ENSURE MOTOR INBOARD BEARING IS LUBRICATED.

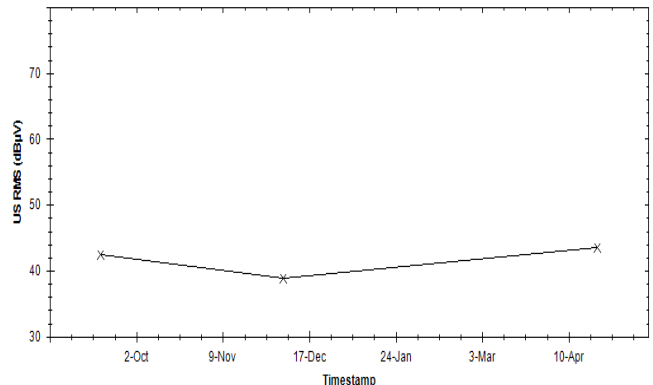
Machine name:	1A AUX HYDRAULIC PUMP 1	Location:	UNIT A
Data collected:	April 10, 2015	STATUS:	NOTATION comments only

OBSERVATIONS: ULTRASOUND REMAINS ELEVATED ON THE MOTOR INBOARD BEARING AND IS LIKELY DUE TO POOR LUBRICATION. CURRENT VIBRATION IS NORMAL. THE TREND TO THE RIGHT IS OF THE MOTOR INBOARD.

RECOMMENDATIONS: ENSURE MOTOR INBOARD BEARING IS LUBRICATED.

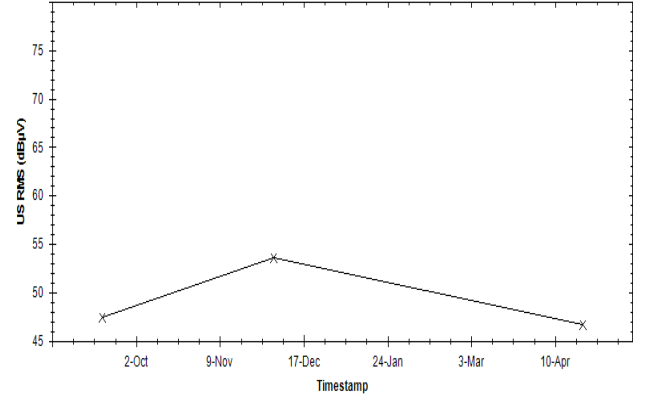
Machine name:	1A DUCT BURNER FAN B	Location:	UNIT A
Data collected:	April 10, 2015	STATUS:	NOTATION comments only

OBSERVATIONS: ELEVATED LEVELS ARE LIKELY DUE TO POOR LUBRICATION. LEVELS DECREASED SIGNIFICANTLY BUT ARE STILL COMPARATIVELY ELEVATED. THE TREND TO THE RIGHT IS OF THE MOTOR OUTBOARD. CURRENT VIBRATION IS NORMAL.

RECOMMENDATIONS: ENSURE MOTOR OUTBOARD BEARING IS LUBRICATED.

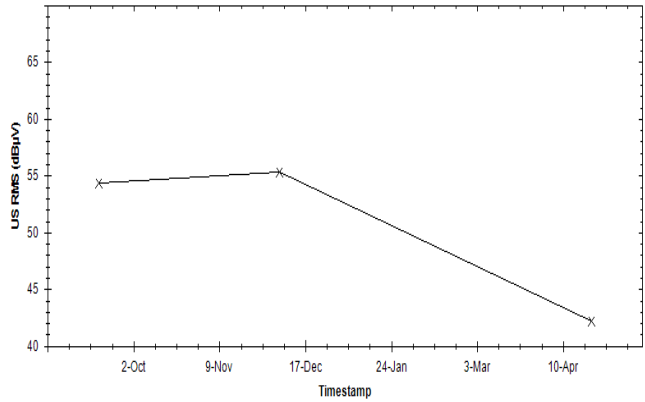
Machine name:	1B LUBE OIL MIST SEPARATION MOTOR 2	Location:	UNIT B
Data collected:	April 10, 2015	STATUS:	NOTATION comments only

OBSERVATIONS: LEVELS DECREASED SIGNIFICANTLY BUT ARE STILL COMPARATIVELY ELEVATED. MAY BE DUE TO LACK OF LUBRICATION. THE TREND TO THE RIGHT IS OF THE MOTOR OUTBOARD. CURRENT VIBRATION IS NORMAL.

RECOMMENDATIONS: ENSURE MOTOR OUTBOARD BEARING IS LUBRICATED.

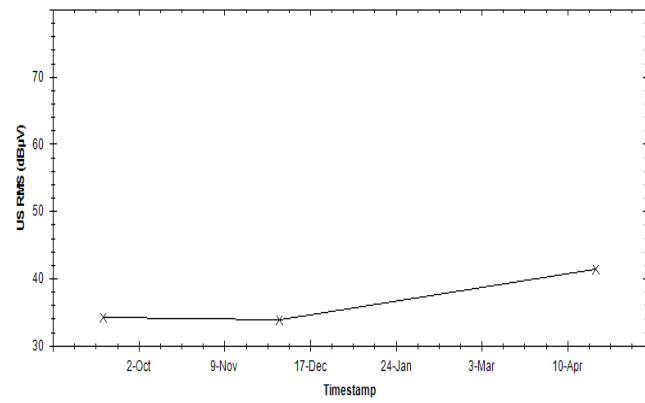
Machine name:	1B EXHAUST FRAME BLOWER 1	Location:	UNIT B
Data collected:	April 10, 2015	STATUS:	NOTATION comments only

OBSERVATIONS: ULTRASOUND LEVELS MAY BE ELEVATED DUE TO LACK OF LUBRICATION. THE TREND TO THE RIGHT IS OF THE MOTOR INBOARD. VIBRATION HAS ELEVATED VANE PASS BUT MOTOR APPEARS NORMAL.

RECOMMENDATIONS: ENSURE MOTOR INBOARD BEARING IS LUBRICATED.
