INFRARED ANALYSIS SURVEY REPORT

Sample Client

Facility A

MCC SCAN

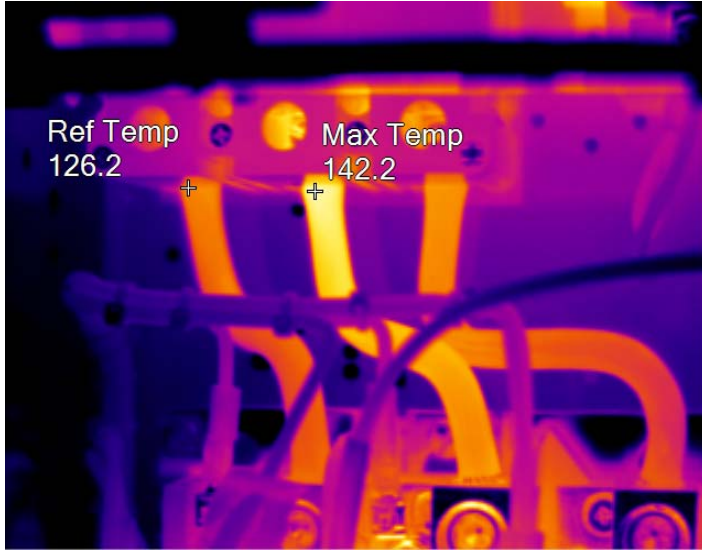
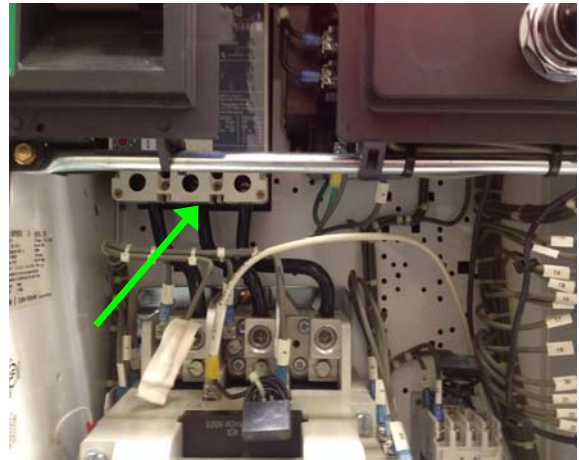
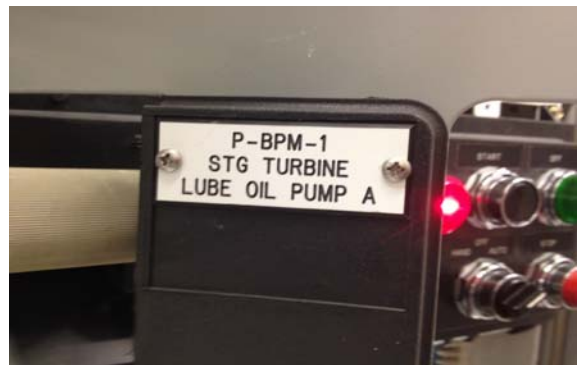
STG Turbine Lube Oil Pump A

Inspection Date:	1/14/2014 10:03:00 AM	Associated Unit:	Steam Turbine
Equipment	STG Lube Oil Pump-A	Description:	Line 2 connection
Recommended Action	Clean and tighten connection	Potential Problem	Loose or corroded connection
Emissivity:	0.95	Repair Priority:	Minor
Camera Manufacturer	Fluke Thermography	Inspected By:	Jesse Vanhoy

Line 2 “load side” appears to have a loose or corroded connection. This could also be due to overtightening. At this time the defect is in very early stages.

Name	Temperature
Ambient Temperature	70°F
Max Temperature	142.2°F
Reference Temperature	126.2°F
Max over Reference Temperature	16°F

Recommend Clean and tighten connection during next maintenance period. Ensure connections are set to correct torque. Rescan in 6 months to verify repairs were effective.

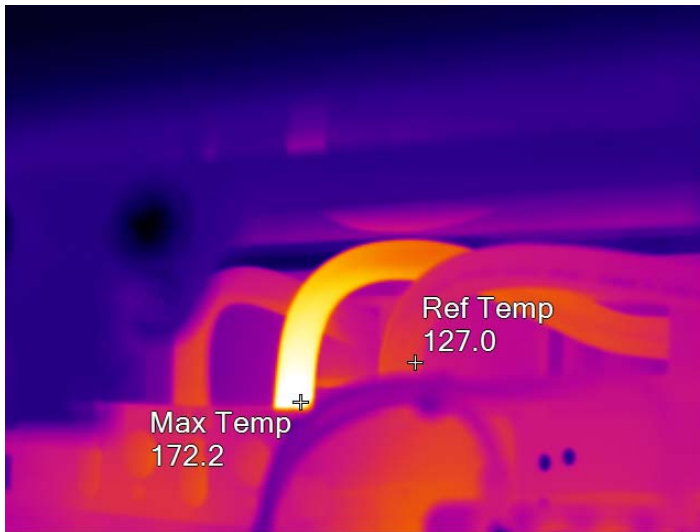
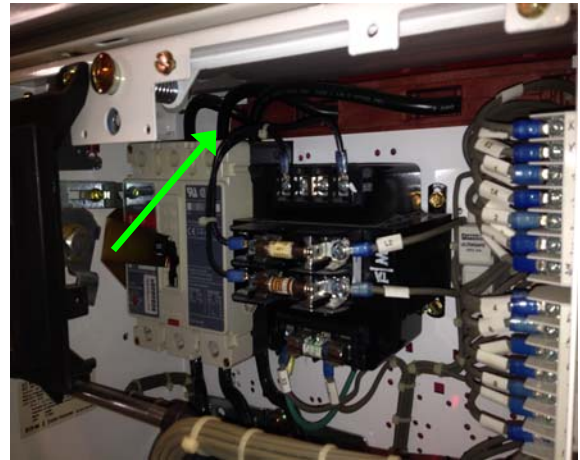
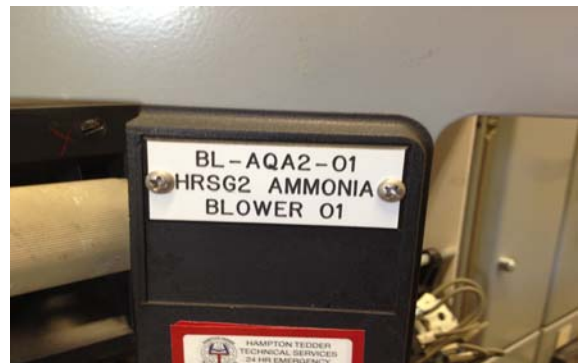
HRSG 2 Ammonia Blower 01

Inspection Date:	1/14/2014 10:43:00 AM	Associated Unit:	HRSG-2
Equipment	Ammonia Blower 01	Description:	Line 2 connection
Recommended Action	Clean and tighten connection	Potential Problem	Loose or corroded connection
Emissivity:	0.95	Repair Priority:	Minor
Camera Manufacturer	Fluke Thermography	Inspected By:	Jesse Vanhoy

Line 2 “line side” appears to have a loose or corroded connection. This could also be due to overtightening. Thermal pattern indicates this defect is in relatively early stages.

Name	Temperature
Ambient Temperature	70°F
Max Temperature	172.2°F
Reference Temperature	127°F
Max over Reference Temperature	45.2°F

Recommend Clean and tighten connection during next maintenance period. Ensure connections are set to correct torque. Rescan in 6 months to verify repairs were effective.

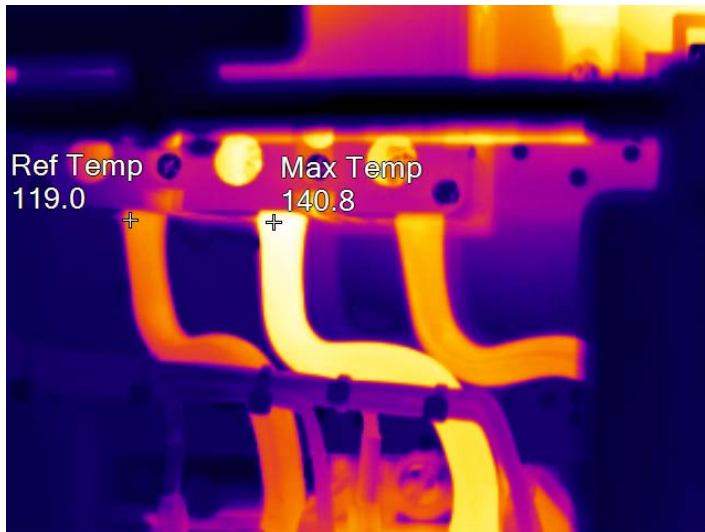
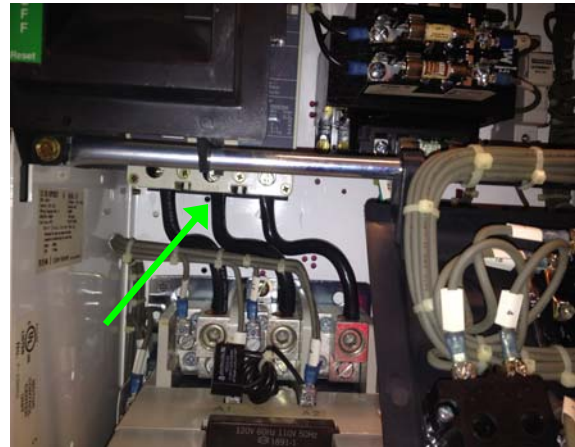
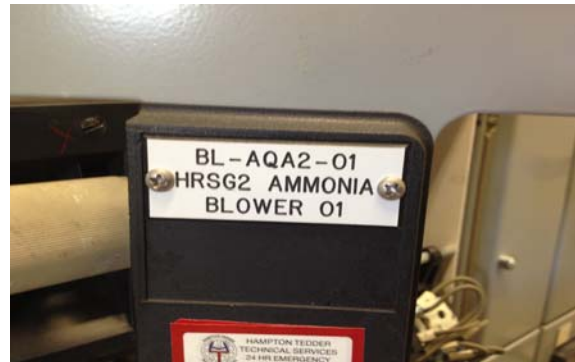
HRSG2 Ammonia Blower 01

Inspection Date:	1/14/2014 10:43:00 AM	Associated Unit:	HRSG-2
Equipment	Ammonia Blower 01	Description:	Line 2 connection
Recommended Action	Clean and tighten connection	Potential Problem	Loose or corroded connection
Emissivity:	0.95	Repair Priority:	Minor
Camera Manufacturer	Fluke Thermography	Inspected By:	Jesse Vanhoy

Line 2 “load side” appears to have a loose or corroded connection. This could also be due to overtightening. Thermal pattern indicates this defect is in relatively early stages.

Name	Temperature
Ambient Temperature	70°F
Max Temperature	140.8°F
Reference Temperature	119°F
Max over Reference Temperature	21.8°F

Recommend Clean and tighten connection during next maintenance period. Ensure connections are set to correct torque. Rescan in 6 months to verify repairs were effective.

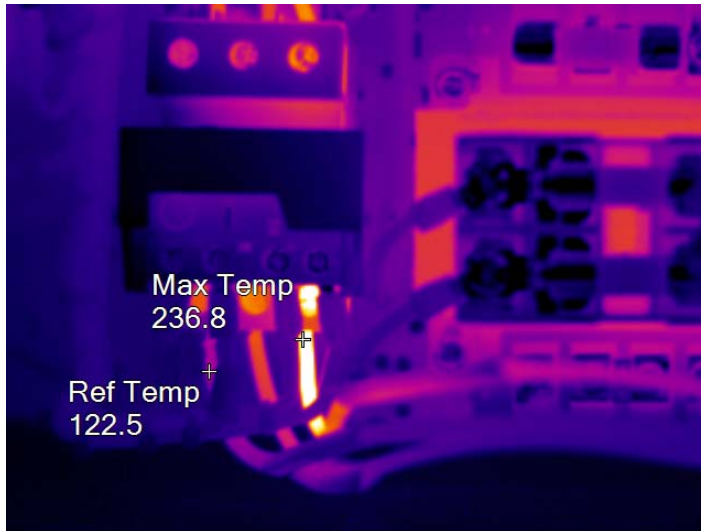
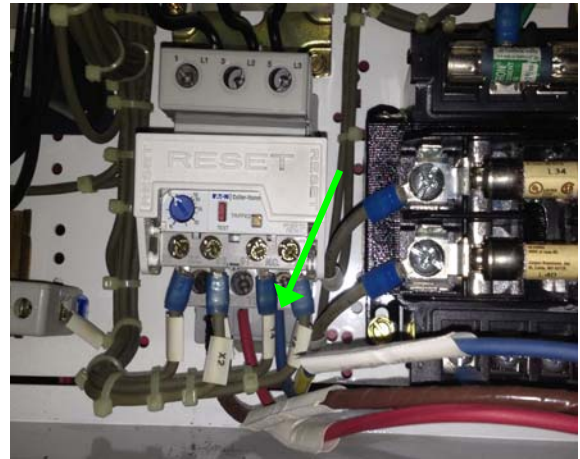
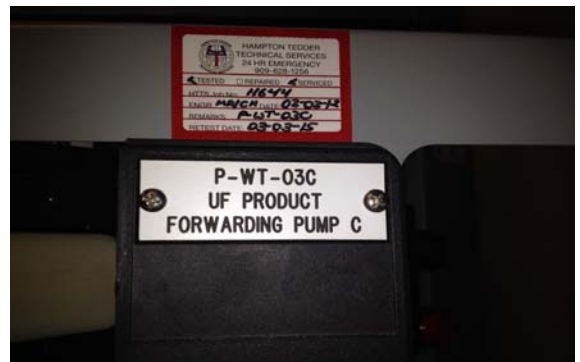
UF Product Forwarding Pump C

Inspection Date:	1/14/2014 12:26:00 PM	Associated Unit:	Water Plant MCC Room
Equipment	Product Forwarding Pump C	Description:	Line 2 connection
Recommended Action	Clean and tighten connection immediately.	Potential Problem	Loose or corroded connection
Emissivity:	0.95	Repair Priority:	Critical
Camera Manufacturer	Fluke Thermography	Inspected By:	Jesse Vanhoy

Line 3 “load side” (second row back with the blue insulation) has an excessive thermal pattern that appears to be due to a loose or corroded connection. At this time the defect is in a critical stage and corrective action should be taken immediately.

Name	Temperature
Ambient Temperature	70°F
Max Temperature	236.8°F
Reference Temperature	122.5°F
Max over Reference Temperature	114.3°F

Recommend Clean and tighten connection immediately. Inspect the line and make sure it has not been compromised due to excessive thermal transfer.

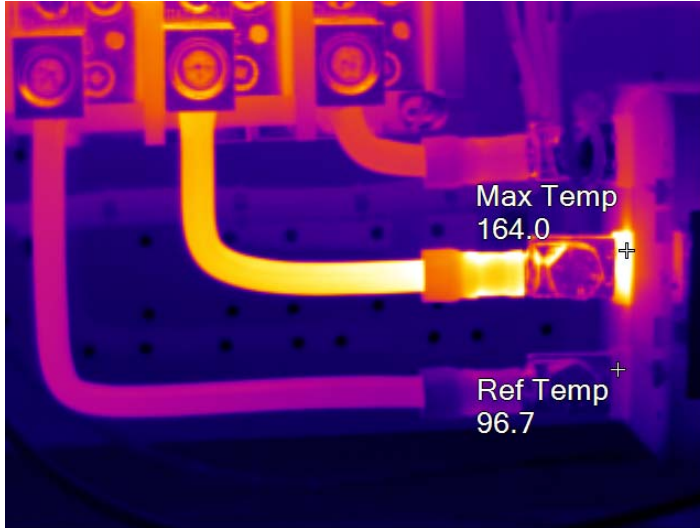
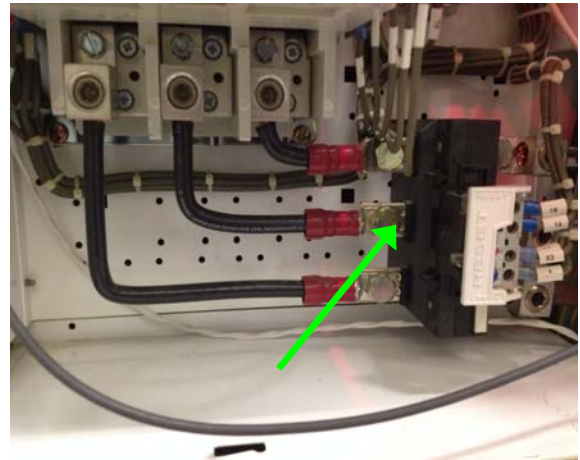
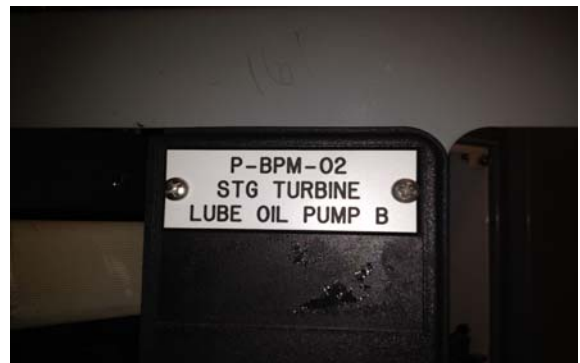
STG Turbine Lube Oil Pump B

Inspection Date:	1/15/2014 10:05:00 AM	Associated Unit:	Steam Turbine
Equipment	STG Lube Oil Pump-B	Description:	Line 2 connection
Recommended Action	Clean and tighten connection ASAP	Potential Problem	Loose or corroded connection
Emissivity:	0.95	Repair Priority:	Moderate
Camera Manufacturer	Fluke Thermography	Inspected By:	Jesse Vanhoy

Line 2 “line side” appears to have a loose or corroded connection. This could also be due to overtightening. At this time the defect is in moderate stages. It also appears to be transferring secondary thermal pattern from line side to load side.

Name	Temperature
Ambient Temperature	70°F
Max Temperature	164°F
Reference Temperature	96.7°F
Max over Reference Temperature	67.3°F

Recommend Clean and tighten connection as soon as possible. Inspect the line and make sure it has not been compromised due to excessive thermal transfer. Ensure connections are set to correct torque. Rescan in 6 months to verify repairs were effective.

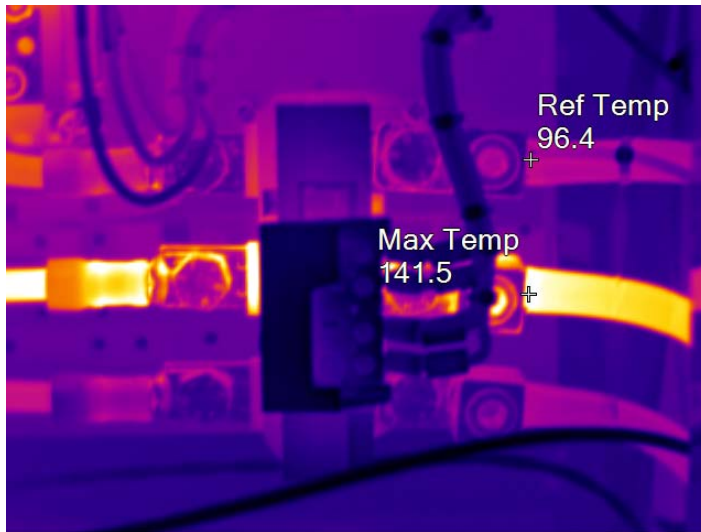
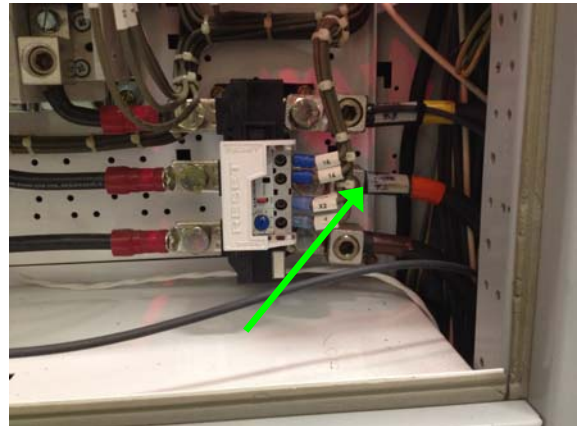
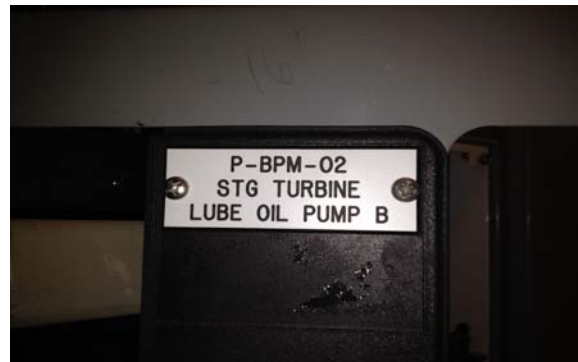
STG Turbine Lube Oil Pump B

Inspection Date:	1/15/2014 10:05:00 AM	Associated Unit:	Steam Turbine
Equipment	STG Lube Oil Pump-B	Description:	Line 2 connection
Recommended Action	Clean and tighten connection	Potential Problem	Loose or corroded connection
Emissivity:	0.95	Repair Priority:	Minor
Camera Manufacturer	Fluke Thermography	Inspected By:	Jesse Vanhoy

Line 2 “load side” appears to have a loose or corroded connection. This could also be due to overtightening. The thermal pattern is not as excessive as line side but is elevated and should be inspected.

Name	Temperature
Ambient Temperature	70°F
Max Temperature	141.5°F
Reference Temperature	96.4°F
Max over Reference Temperature	45.1°F

Recommend Clean and tighten connection during next maintenance period. Ensure connections are set to correct torque. Rescan in 6 months to verify repairs were effective.
