VIBRATION ANALYSIS AND BALANCE REPORT

Sample Facility

Main Gas Turbine Generator

Subject: Vibration Analysis And Balance of Main Gas Turbine Generator

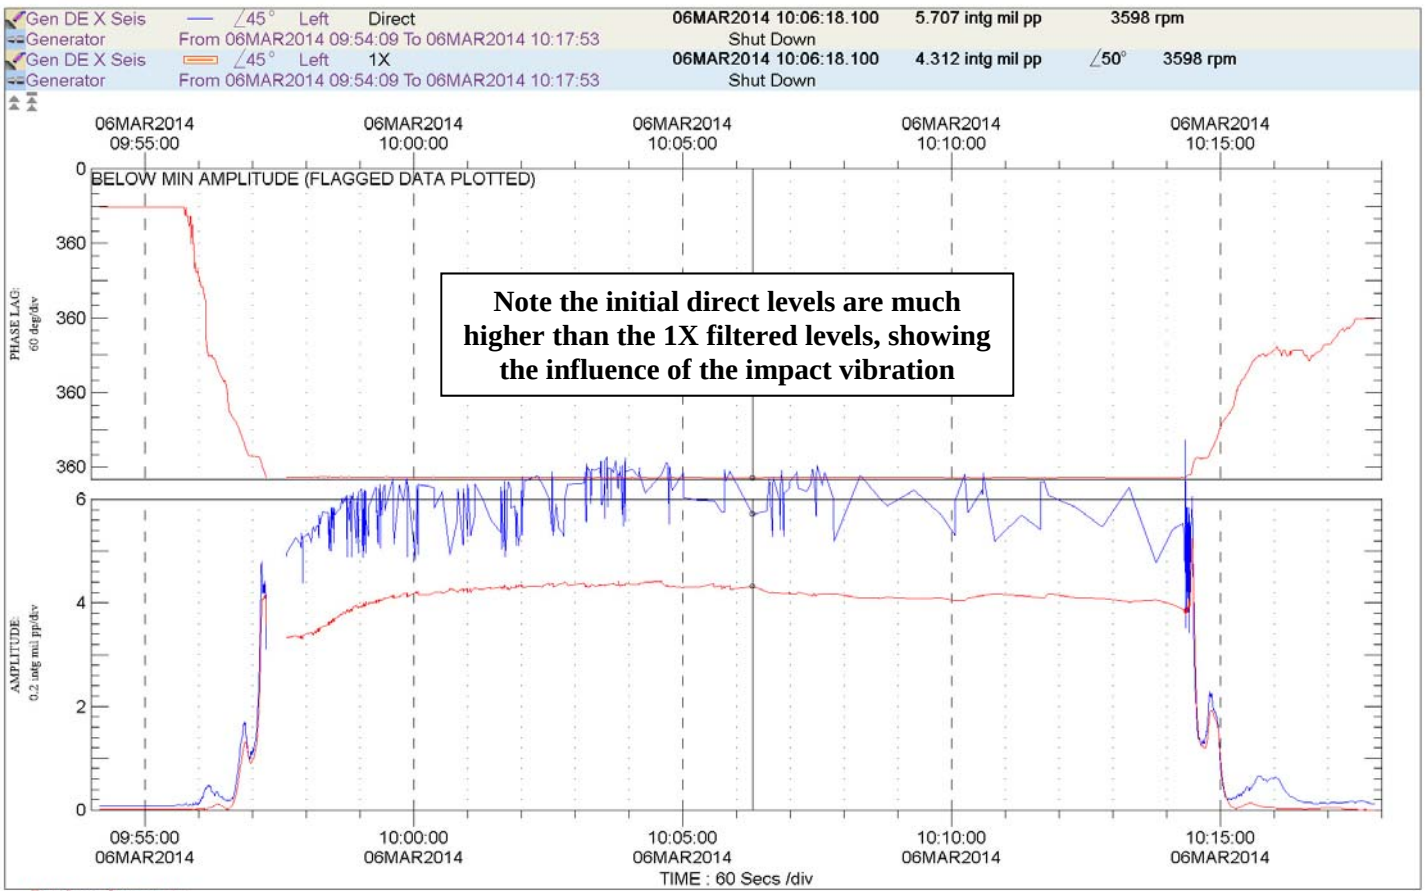
An ADRE instrument was connected directly to the proximiters, seismic probes were mounted to the pedestals, and a laser tachometer was set up for speed and phase reference. Initial startup to minimum load revealed both high shaft and pedestal seismic levels at speed and loads (see Figure 1, showing a listing of the initial filtered data for each point, and Figures 3&5, showing the trend of both the initial shaft and pedestal data). The frequency content of the vibration showed similar data to previous surveys; with sideband peaks around the 1X component indicating strong impacts of the shaft on the thrust pads (see Figure 9 showing the initial Waterfall spectrum plots).

Figure 3 - DE Pedestal Direct and Filtered Vibration Trend for Initial Run

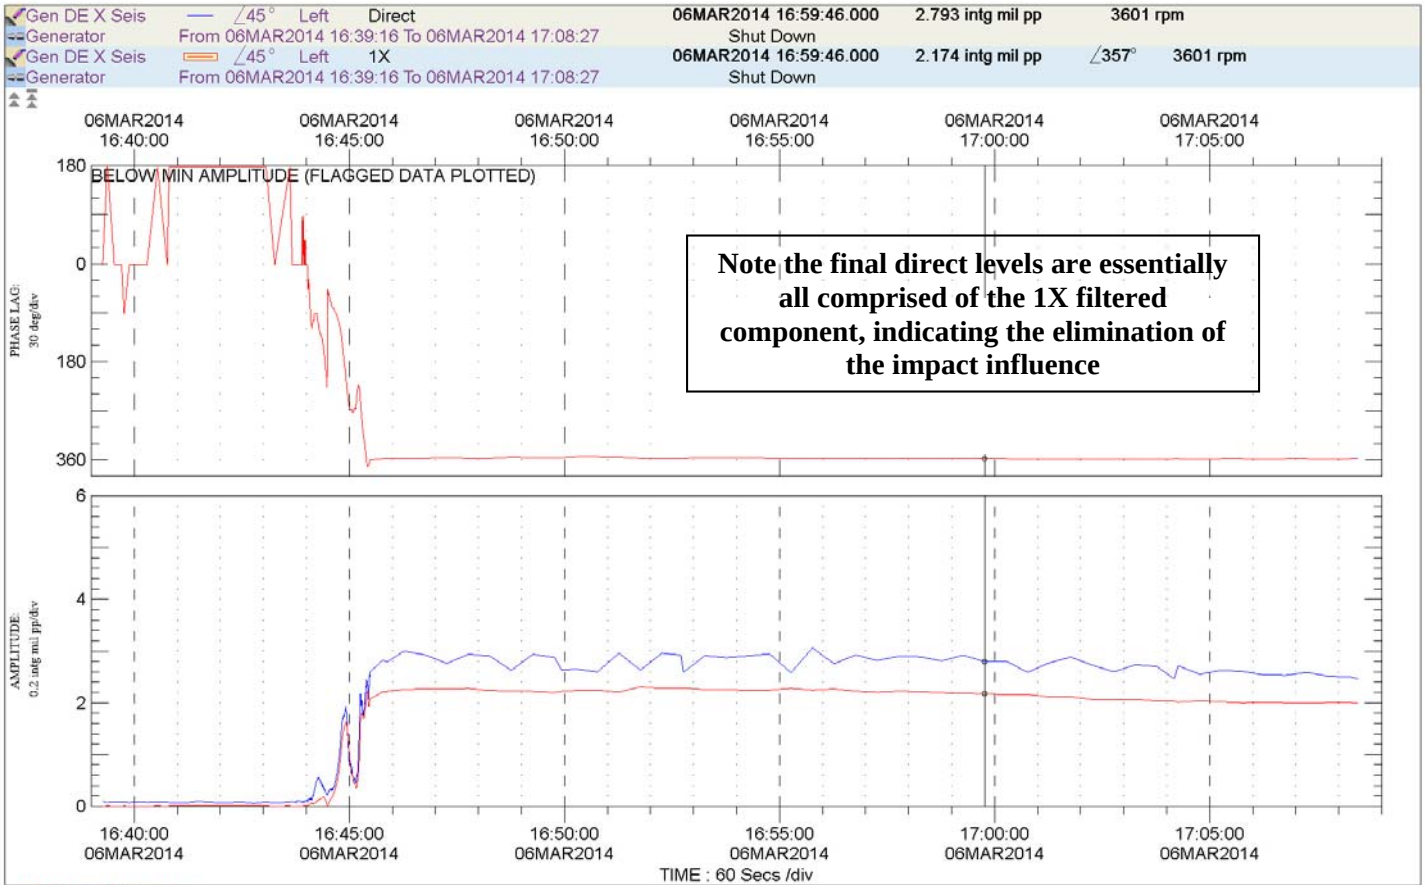
A couple pair balance shots of 14.7 ounces placed 180° opposite each other on both ends resulted in reduced vibration levels on both the shaft and pedestal measurements (see final data listing, Figure 2, and final shaft and pedestal trend plots, Figure 4&6). More importantly, by eliminating the large couple component on the rotor, the axial hunting of the shaft and the resultant impact at the pedestals was also eliminated (see Figure 8, showing the final Polar plot, and Figure 10, showing the final Waterfall spectrum plots). It is believed this occurred as a result of the reduction in the “crank” effect on the unit. It is also felt that the correction of both the unit level and the drive end pedestal soft foot was beneficial in lining up the imbalance as a large couple, allowing the field trim balance to succeed with minimal weight changes.

Figure 4- DE Pedestal Direct and Filtered Vibration Trend for Final Run

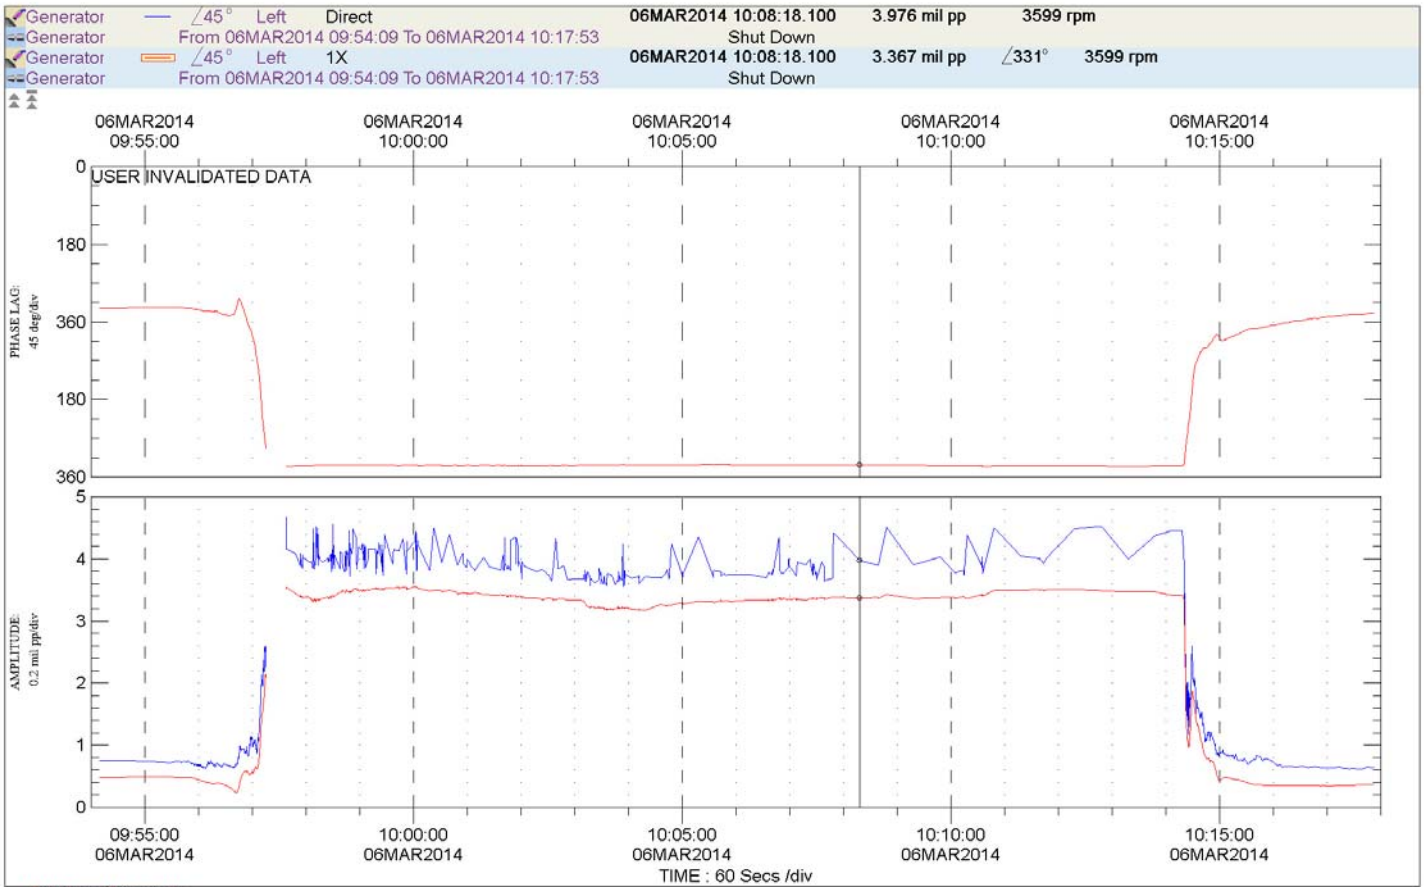
Figure 5 - NDE Shaft Relative Direct and Filtered Vibration Trend for Initial Run

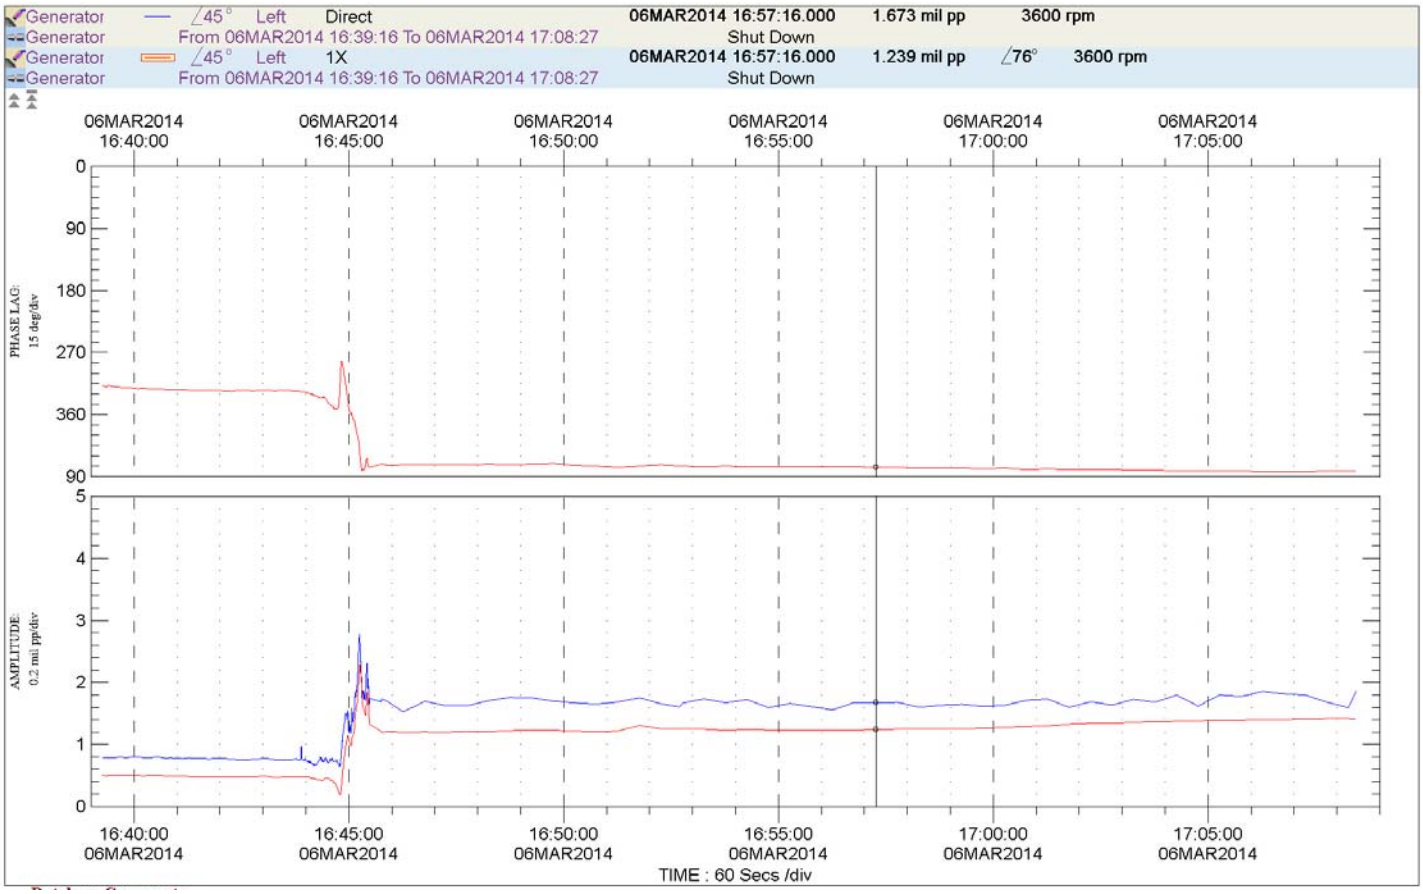
Figure 6 - NDE Shaft Relative Direct and Filtered Vibration Trend for Final Run

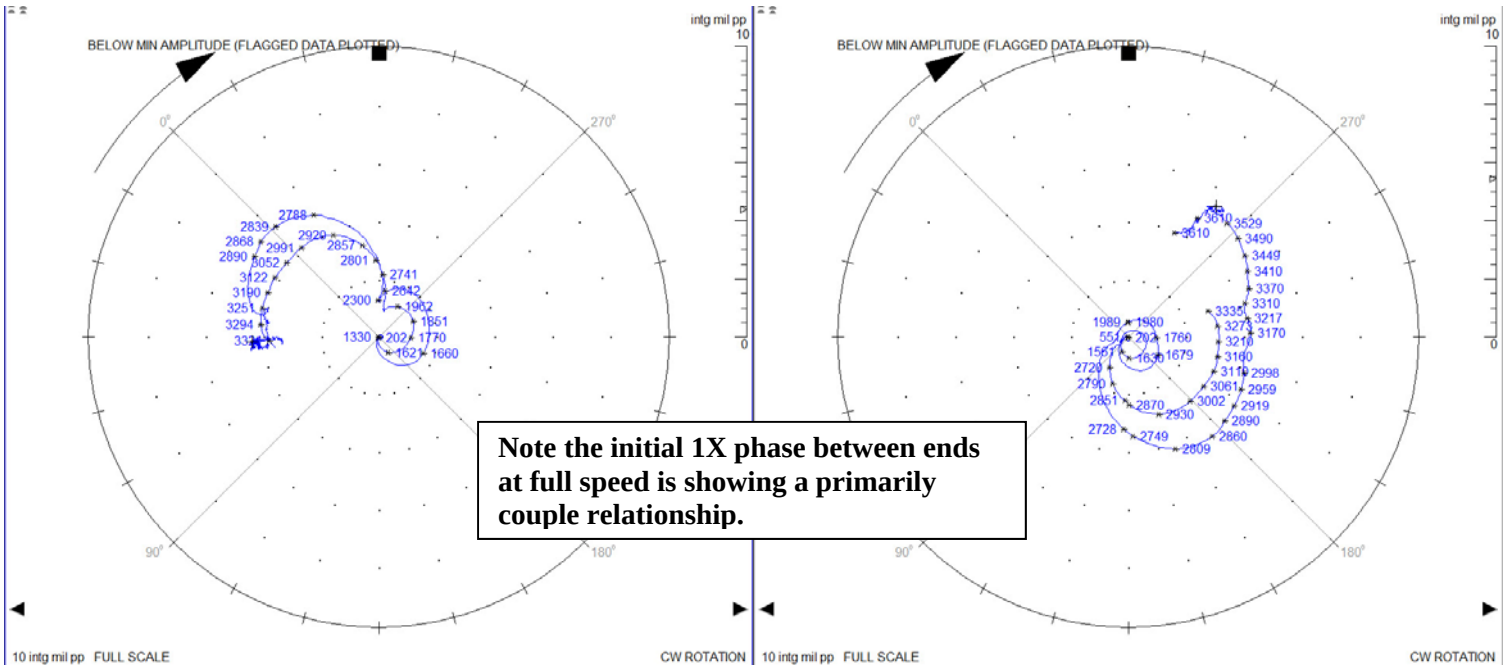
However, one significant difference from past data was that the bearing-to-bearing phase relationship was now primarily out-of-phase, indicating a strong couple (dynamic) force acting on the rotor (see initial data polar plot, Figure 7). This condition made it conducive to an in-situ trim balance.

Figure 7 - Pedestal Filtered Vibration Polar Plots for Initial Run

Note the initial 1X phase between ends at full speed is showing a primarily couple relationship.

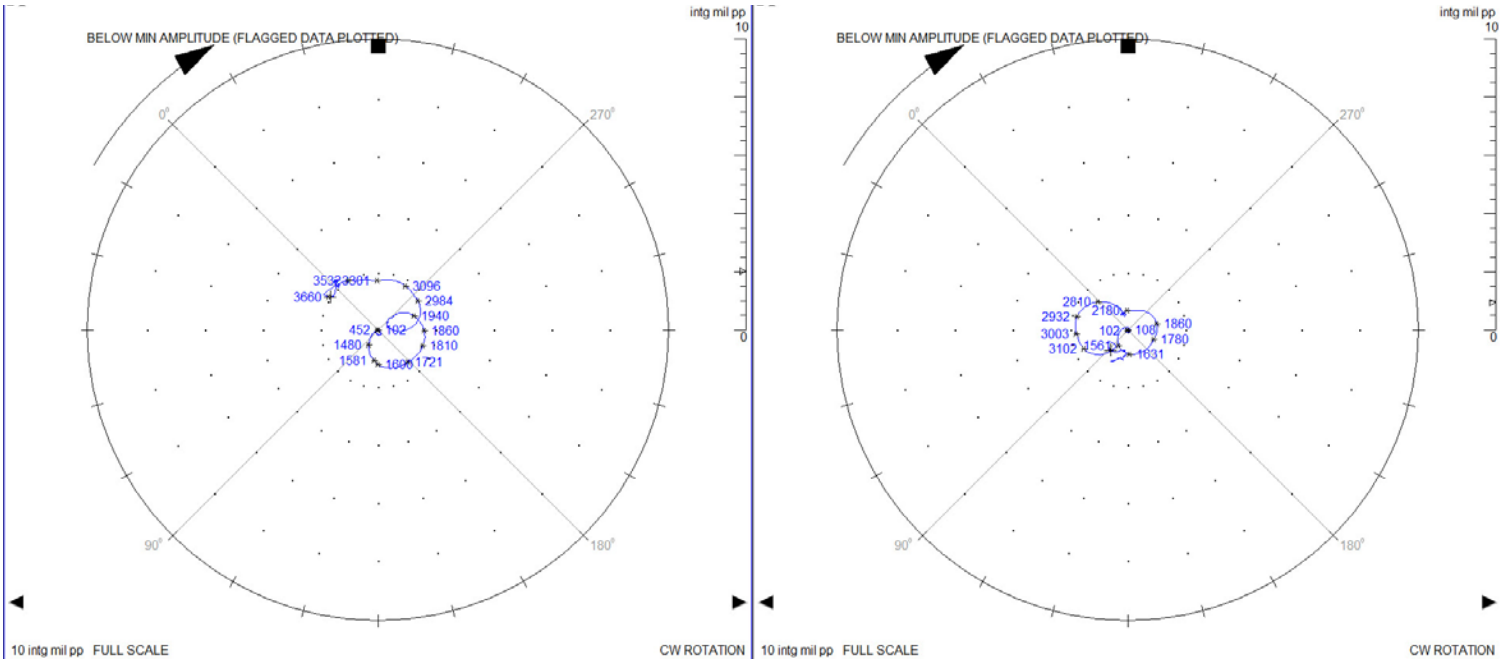
Figure 8 - Pedestal Filtered Vibration Polar Plots for Final Run

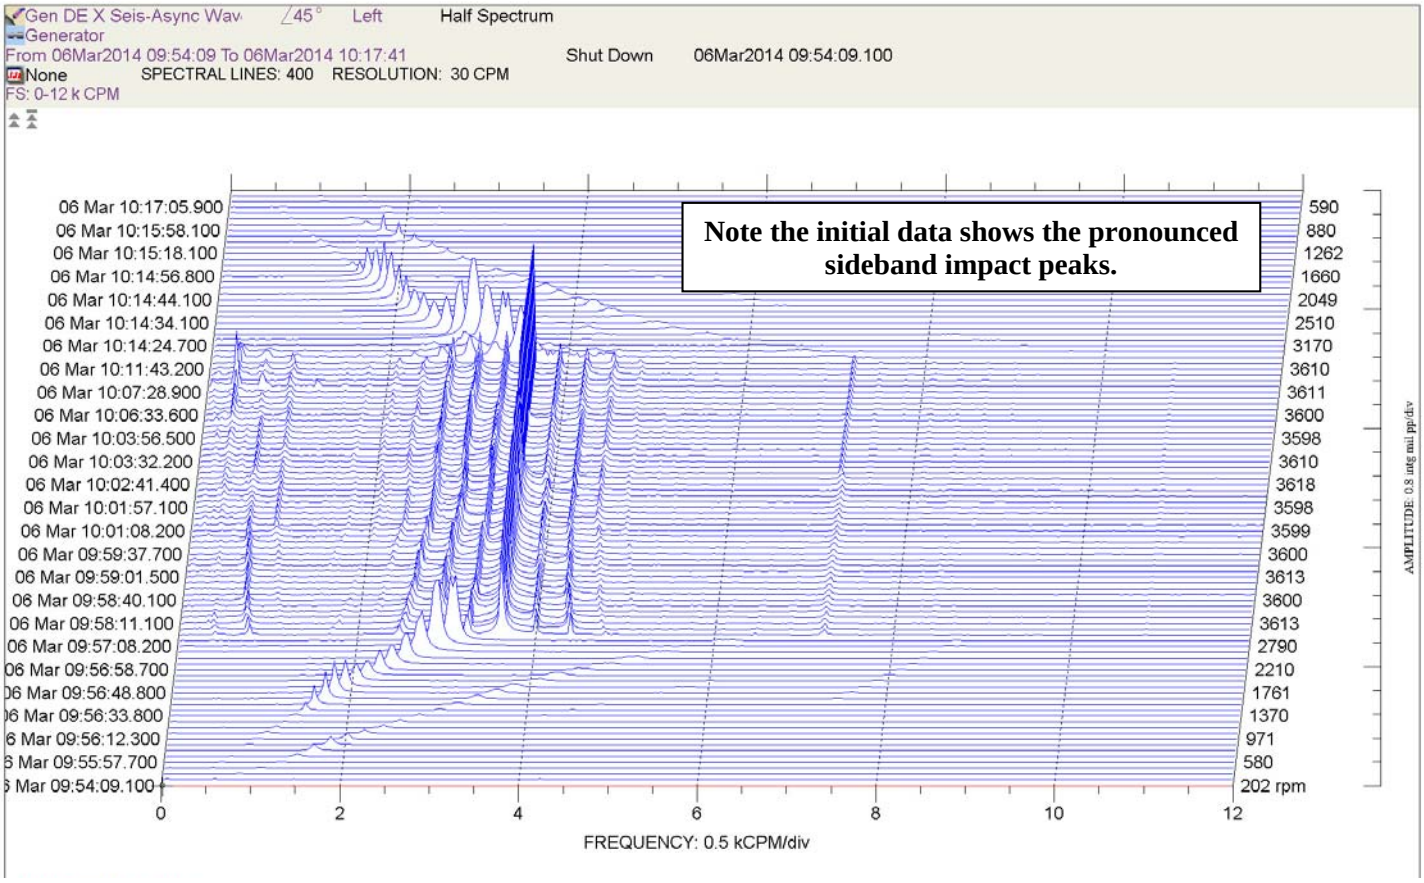
Figure 9 - Pedestal Waterfall Plot for Initial Run
