INFRARED ANALYSIS SURVEY REPORT

SAMPLE CLIENT REPORT

Facility A

DATA COLLECTED: December 2015

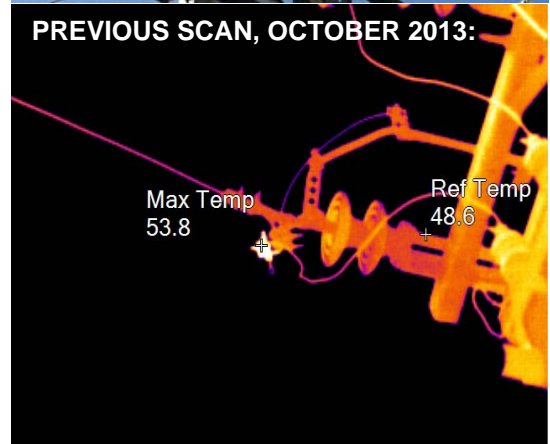
Pole E3 Next To The Reclosure

Inspection Date:	12/12/13	Location	
Equipment	Pole E3 Next to the Reclosure	Equipment Name:	Hot Line Connection
Recommended Action	Clean and tighten connection.	Potential Problem	Loose or corroded connection
Emissivity:	0.94	Repair Priority:	Moderate
Camera Manufacturer	Fluke Thermography	Inspected By:	Justin Hanscom

Comments: This left side line has a hot clamp connection defect. It has been reported on multiple times and has continued to increase in temperature.

Name	Temperature
Ambient Temperature	65°F
Defect Max Temperature	150.2°F
Reference Temperature	81.4°F
Defect vs. Reference Delta Temp.	68.8°F
Defect Rise Above Ambient	85.2°F

Recommendations: Connection needs to be cleaned and inspected for any further damage.
