Prepared For: Sample Client
Facility : Power Gen Facility
Equipment: WSAC Exchanger Cooling Fan
Location: WSAC CCW SYSTEM

Component: WSAC FIN FAN COOLER
Description: 1H Motor Drive Sheave
View aspect: Direct
Severity: Moderate

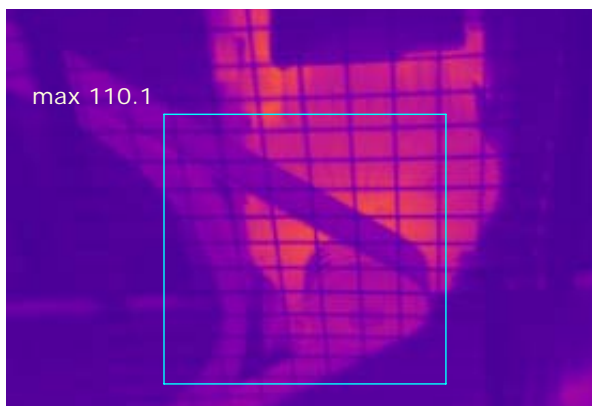
COMPARATIVE NORMAL IMAGE:

Comments: Excessive temperature on motor sheave.
Recommend: Perform vibration analysis on motor to determine source of problem. Not a typical loose belt signature as the belt temperature is not excessive.
